# Home Report

1/2 Rustic Place 3 Dudhope Street  
Dundee DD1 1JZ

# single survey

## survey report on:

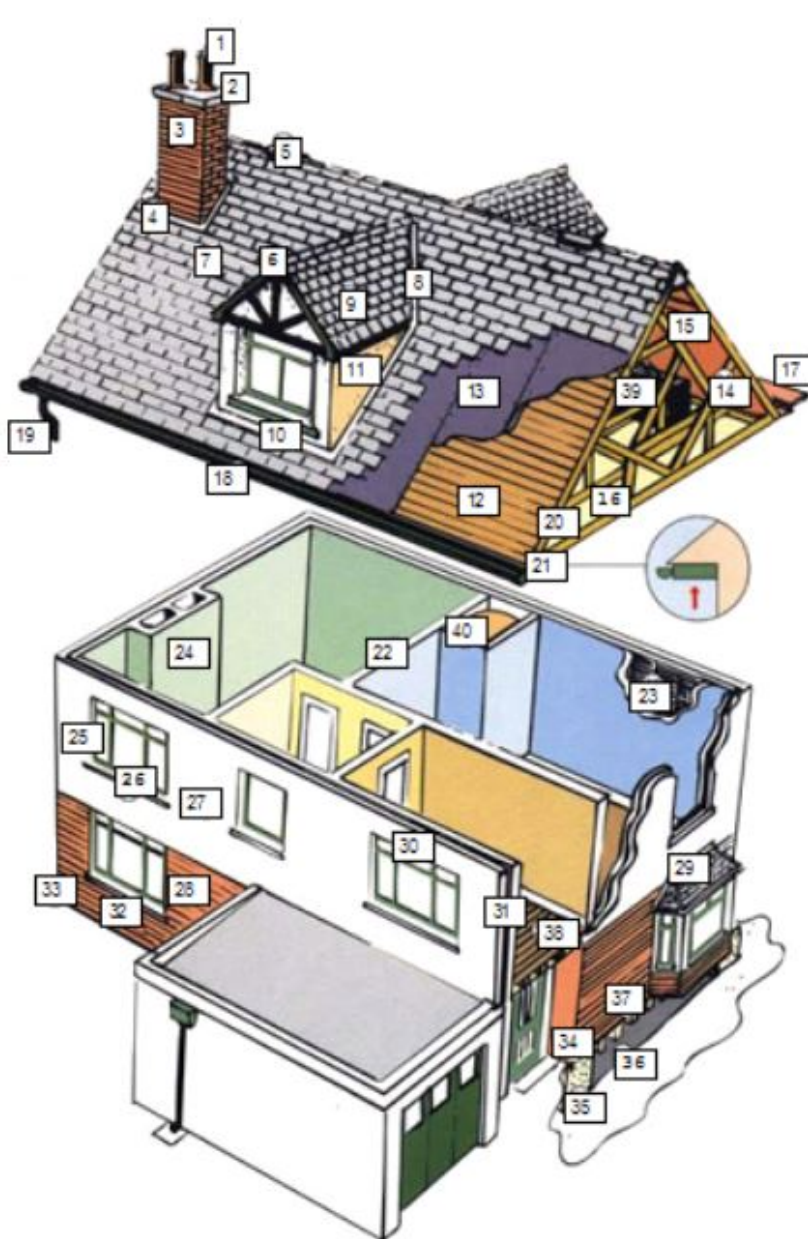
## Sectional Diagram showing elements of a typical house

1	Chimney pots
2	Coping stone
3	Chimney head
4	Flashing
5	Ridge ventilation
6	Ridge board
7	Slates/tiles
8	Valley guttering
9	Dormer projection
10	Dormer flashing
11	Dormer cheeks
12	Sarking
13	Roof felt
14	Trusses
15	Collar
16	Insulation
17	Parapet gutter
18	Eaves guttering
19	Rainwater downpipe
20	Verge boards / skewes
21	Soffit boards
22	Partition wall
23	Lath / plaster
24	Chimney breast
25	Window pointing
26	Window sills
27	Rendering
28	Brickwork / pointing
29	Bay window projection
30	Lintels
31	Cavity walls / wall ties
32	Subfloor ventilator
33	Damp proof course
34	Base course
35	Foundations
36	Solum
37	Floor joists
38	Floorboards
39	Water tank
40	Hot water tank

Reference may be made in this report to some or all of the above component parts of the property. This diagram may assist you in locating and understanding these items.

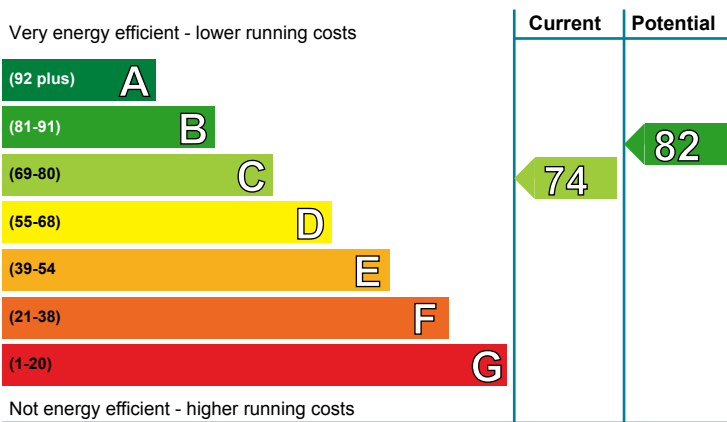
## Energy Efficiency Rating

This graph shows the current efficiency of your home, taking into account both energy efficiency and fuel costs. The higher this rating, the lower your fuel bills are likely to be.

Your current rating is **band C (74)**. The average rating for EPCs in Scotland is **band D (61)**.

The potential rating shows the effect of undertaking all of the improvement measures listed within your recommendations report.

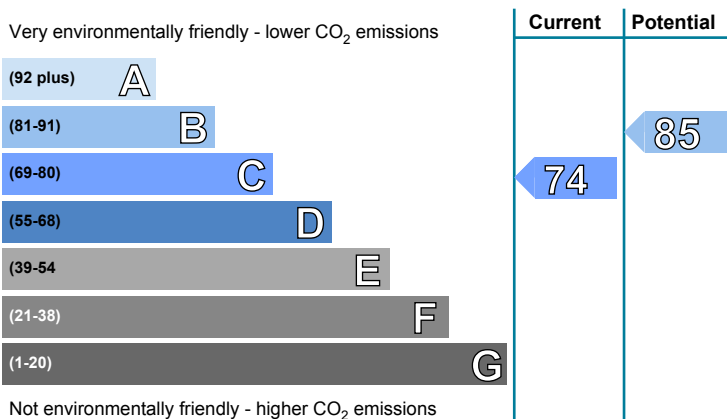
## Environmental Impact (CO<sub>2</sub>) Rating

This graph shows the effect of your home on the environment in terms of carbon dioxide (CO<sub>2</sub>) emissions. The higher the rating, the less impact it has on the environment.
