Home Report

333 Perth Road
Dundee DD2 1LQ

Property address	333 Perth Road Dundee DD2 1LQ
Customer	James Gillan
Prepared by	Graham + Sibbald LLP

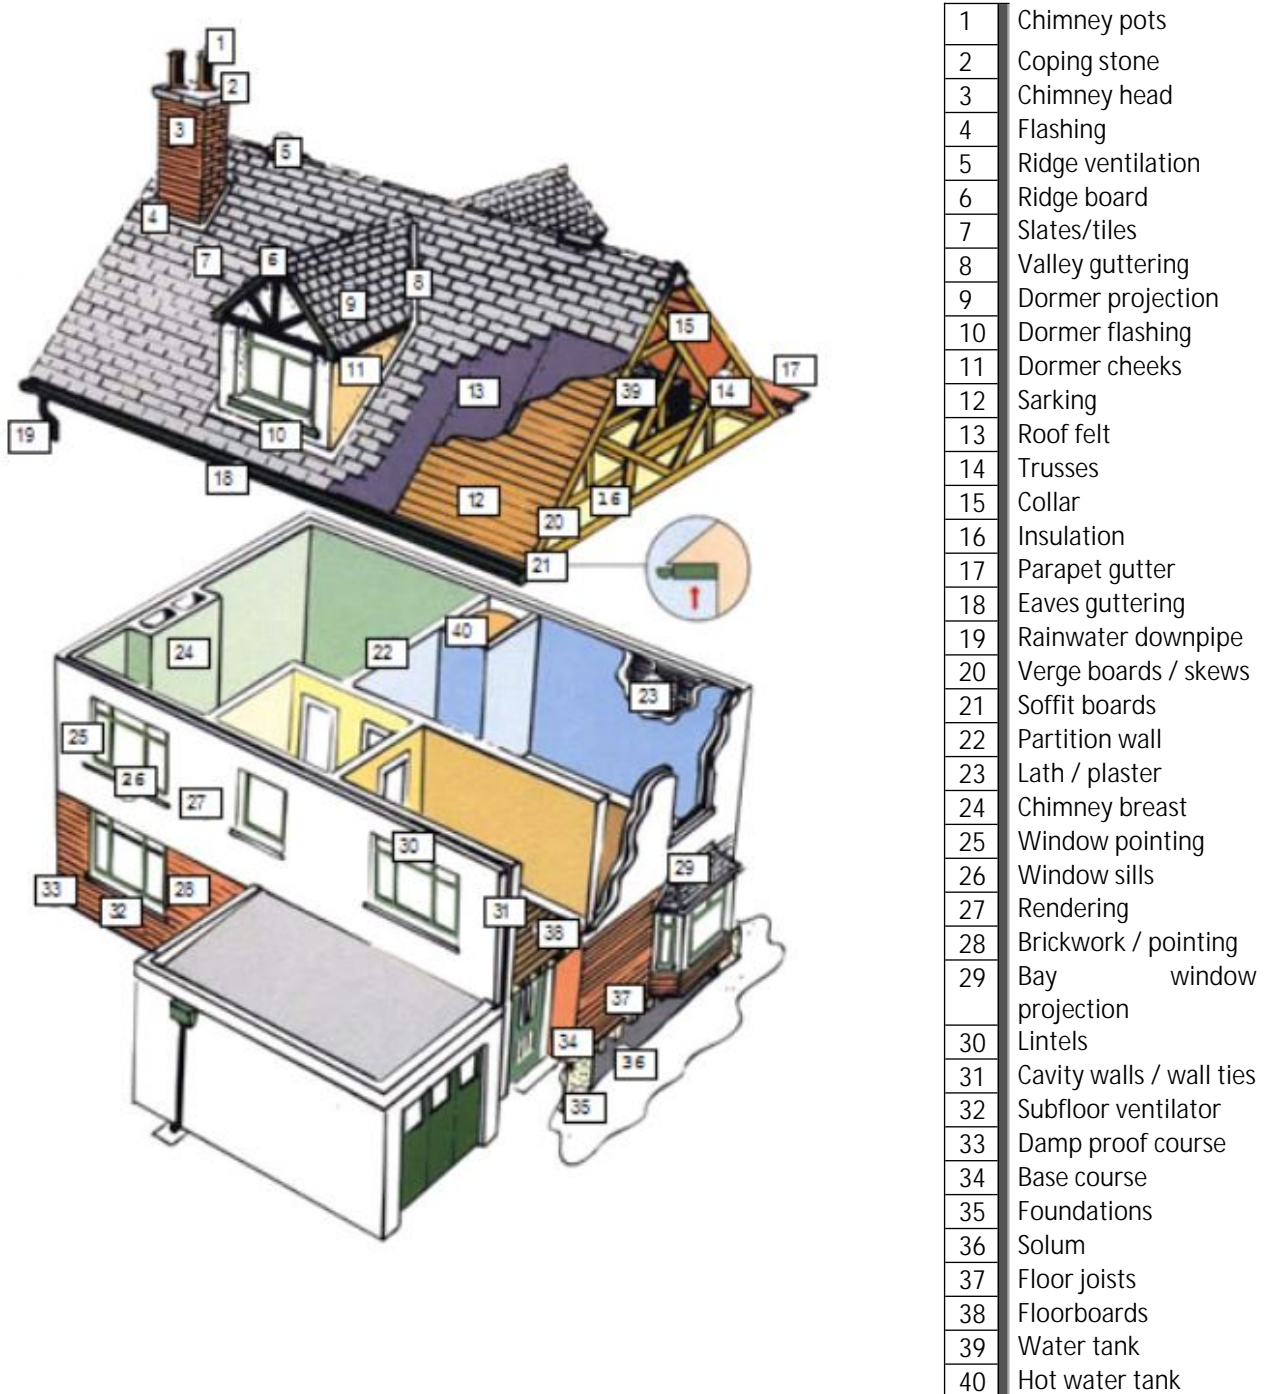
Sectional Diagram showing elements of a typical house

Reference may be made in this report to some or all of the above component parts of the property. This diagram may assist you in locating and understanding these items.
