# Home Report

Two Aystree 26 Victoria Road  
Broughty Ferry Dundee DD5 1BJ

# single survey

<b>Property address</b>	Two Aystree 26 Victoria Road Dundee DD5 1BJ
<b>Customer</b>	Shirley Henderson
<b>Prepared by</b>	Graham + Sibbald LLP

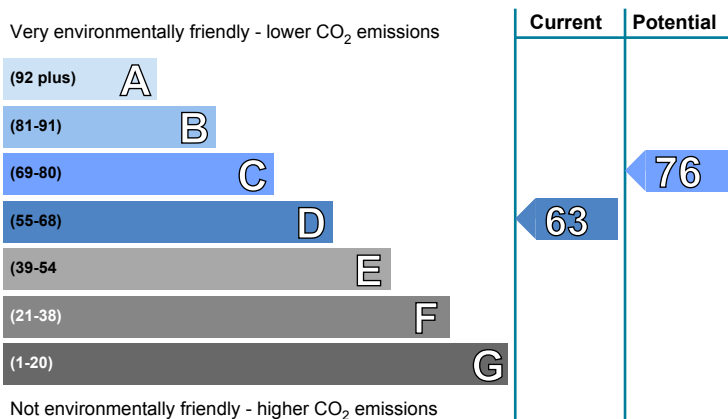
## Environmental Impact (CO<sub>2</sub>) Rating

This graph shows the effect of your home on the environment in terms of carbon dioxide (CO<sub>2</sub>) emissions. The higher the rating, the less impact it has on the environment.
