Home Report

124A Gray Street Broughty Ferry Dundee DD5 2DG

survey report on:

Property address	
, , , , , , , , , , , , , , , , , , ,	124A Gray Street
	Dundee
	DD5 2DG

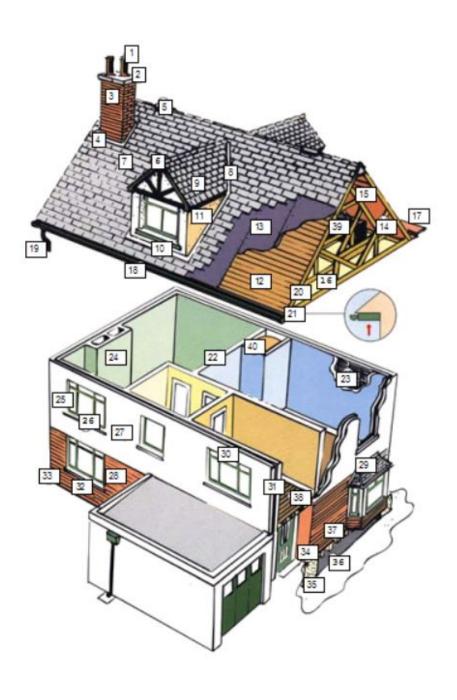
Sectional Diagram showing elements of a typical house

- 1 Chimney pots
- 2 Coping stone
- 3 Chimney head
- 4 Flashing
- 5 Ridge ventilation
- 6 Ridge board
- 7 Slates/tiles
- 8 Valley guttering
- 9 Dormer projection
- 10 Dormer flashing
- 11 Dormer cheeks
- 12 Sarking
- 13 Roof felt
- 14 Trusses
- 15 Collar
- 16 Insulation
- 17 Parapet gutter
- 18 Eaves guttering
- 19 Rainwater downpipe
- 20 Verge boards / skews
- 21 Soffit boards
- 22 Partition wall
- 23 Lath / plaster
- 24 Chimney breast
- 25 Window pointing
- 26 Window sills
- 27 Rendering
- 28 Brickwork / pointing
- 29 Bay window
 - projection
- 30 Lintels
- 31 Cavity walls / wall ties
- 32 Subfloor ventilator
- 33 Damp proof course
- 34 Base course
- 35 Foundations
- 36 Solum
- 37 Floor joists
- 38 Floorboards
- 39 Water tank
- 40 Hot water tank

Reference may be made in this report to some or all of the above component parts of the property. This diagram may assist you in locating and understanding these items.
