espc:home report

Single Survey

Property address	5 Westbarn Road, Broughty Ferry, Dundee, DD5 2SS
-------------------------	---

Prepared by	Graham & Sibbald
--------------------	------------------

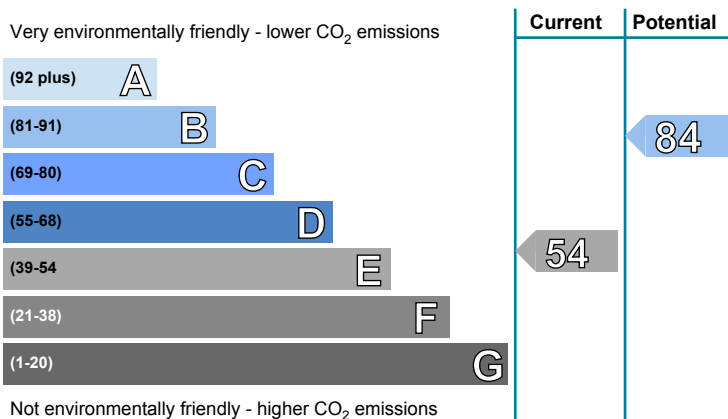
Environmental Impact (CO₂) Rating

This graph shows the effect of your home on the environment in terms of carbon dioxide (CO₂) emissions. The higher the rating, the less impact it has on the environment.
