Home Report

Flat 2A 7 St Peter Street Dundee DD1 4JJ

Date of Valuation: 21/08/2024

survey report on:

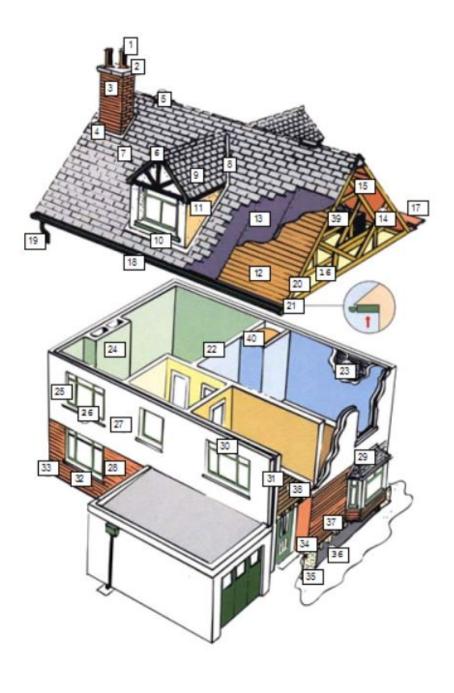
Sectional Diagram showing elements of a typical house
