# Home Report

6 Rugby Terrace  
Broughty Ferry Dundee DD5 2EQ

# single survey

<b>Property address</b>	6 Rugby Terrace Dundee DD5 2EQ
<b>Customer</b>	Evelyn Watson
<b>Prepared by</b>	Graham + Sibbald LLP

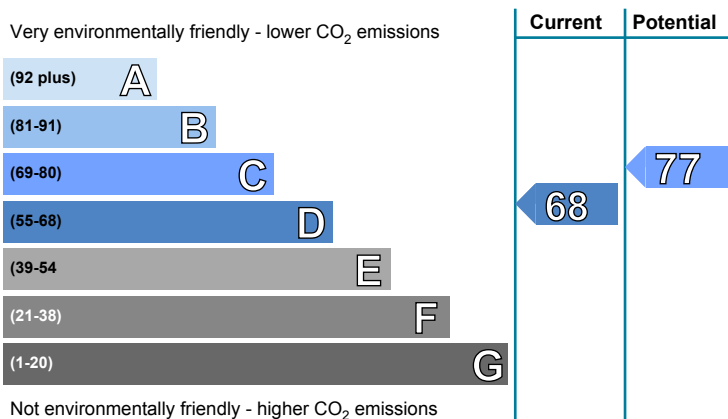
## Environmental Impact (CO<sub>2</sub>) Rating

This graph shows the effect of your home on the environment in terms of carbon dioxide (CO<sub>2</sub>) emissions. The higher the rating, the less impact it has on the environment.
