Home Report

Moiben Main Street Barry Carnoustie DD7 7RP

survey report on:

Property address	Moiben Main Street Carnoustie DD7 7RP
Customer	Joe Duncan
Prepared by	Graham + Sibbald LLP

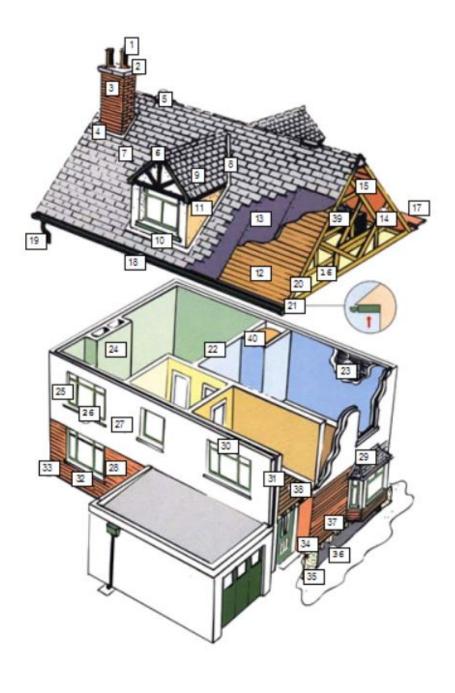
Sectional Diagram showing elements of a typical house

1	Chimney pots
2	Coping stone
3	Chimney head
4	Flashing
5	Ridge ventilation
6	Ridge board
7	Slates/tiles
8	Valley guttering
9	Dormer projection
10	Dormer flashing
11	Dormer cheeks
12	Sarking
13	Roof felt
14	Trusses
15	Collar
16	Insulation
17	Parapet gutter
18	Eaves guttering
19	Rainwater downpipe
20	Verge boards / skews
21	Soffit boards
22	Partition wall
23	Lath / plaster
24	Chimney breast
25	Window pointing
26	Window sills
27	Rendering
28	Brickwork / pointing
29	Bay window
	projection
30	Lintels
31	Cavity walls / wall ties
32	Subfloor ventilator
33	Damp proof course
34	Base course
35	Foundations
36	Solum
37	Floor joists
38	Floorboards
39	Water tank
40	Hot water tank

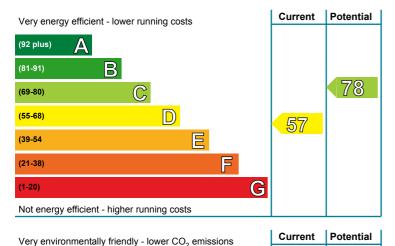
Energy Efficiency Rating

This graph shows the current efficiency of your home, taking into account both energy efficiency and fuel costs. The higher this rating, the lower your fuel bills are likely to be.
