espc::home report

6 St Fillans Place
Dundee
DD3 9HZ
20/06/2024

Single Survey

Property address	6 St Fillans Place, Dundee, DD3 9HZ
-------------------------	---

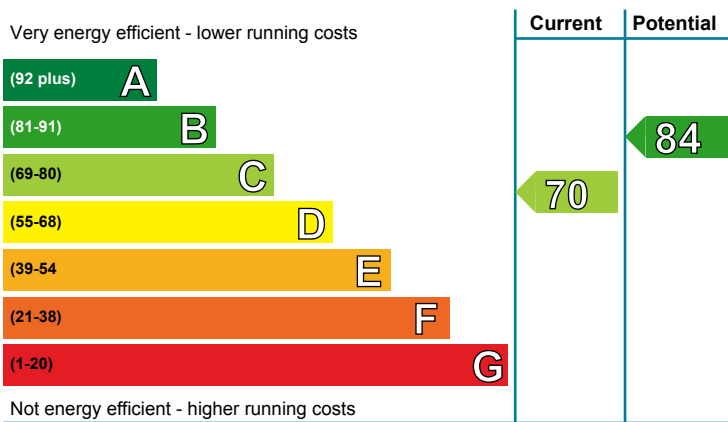
Energy Efficiency Rating

This graph shows the current efficiency of your home, taking into account both energy efficiency and fuel costs. The higher this rating, the lower your fuel bills are likely to be.

Your current rating is **band C (70)**. The average rating for EPCs in Scotland is **band D (61)**.

The potential rating shows the effect of undertaking all of the improvement measures listed within your recommendations report.

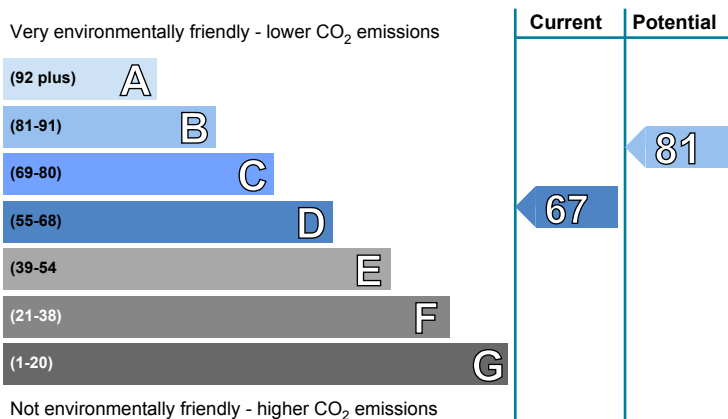
Environmental Impact (CO₂) Rating

This graph shows the effect of your home on the environment in terms of carbon dioxide (CO₂) emissions. The higher the rating, the less impact it has on the environment.
