Home Report

Single Survey

Property address	19 Mill Road Invergowrie Dundee DD2 5BB
Customer	Gill Bringhurst
Customer address	19 Mill Road Invergowrie Dundee DD2 5BB
Prepared by	Shepherd Chartered Surveyors
Date of inspection	26/08/2024

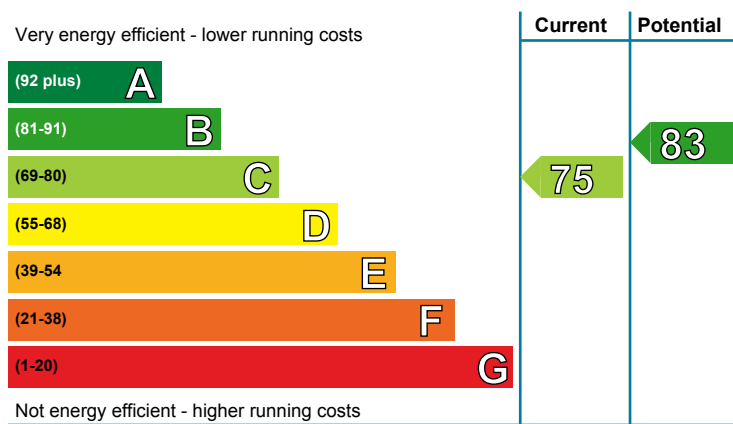
Energy Efficiency Rating

This graph shows the current efficiency of your home, taking into account both energy efficiency and fuel costs. The higher this rating, the lower your fuel bills are likely to be.

Your current rating is **band C (75)**. The average rating for EPCs in Scotland is **band D (61)**.

The potential rating shows the effect of undertaking all of the improvement measures listed within your recommendations report.

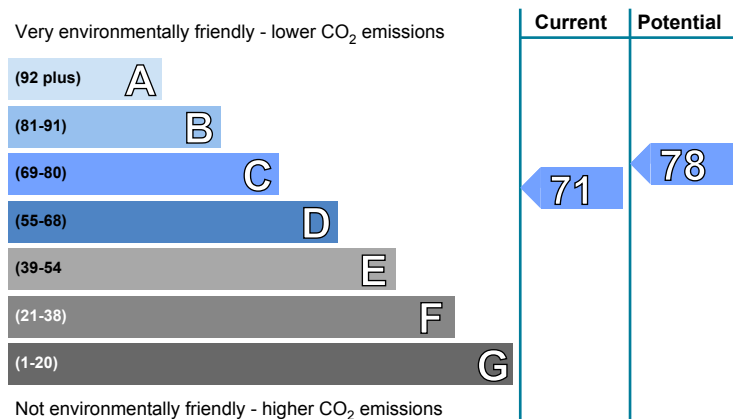
Environmental Impact (CO₂) Rating

This graph shows the effect of your home on the environment in terms of carbon dioxide (CO₂) emissions. The higher the rating, the less impact it has on the environment.
