# Home Report

3/L 99 Arbroath Road  
Dundee DD4 6HW

# single survey

<b>Property address</b>	3/L 99 Arbroath Road Dundee DD4 6HW
<b>Customer</b>	The late Mrs Martha Whyte Sword
<b>Prepared by</b>	Graham + Sibbald LLP

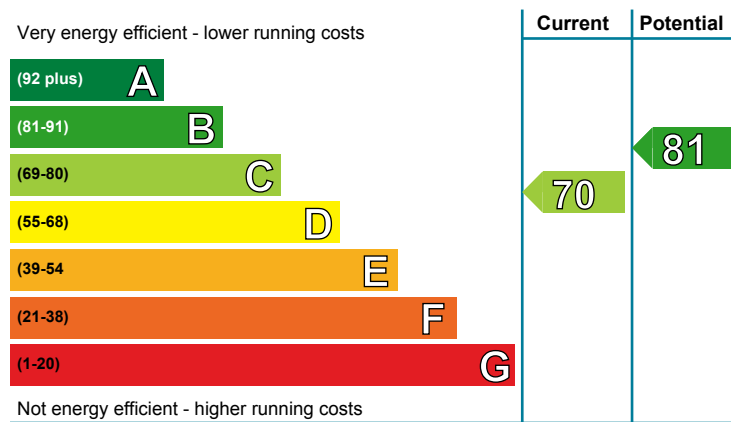
## Energy Efficiency Rating

This graph shows the current efficiency of your home, taking into account both energy efficiency and fuel costs. The higher this rating, the lower your fuel bills are likely to be.

Your current rating is **band C (70)**. The average rating for EPCs in Scotland is **band D (61)**.

The potential rating shows the effect of undertaking all of the improvement measures listed within your recommendations report.
