Home Report

North March Old Dronley Road
Backmuir of Liff Dundee DD2 5QT

Property address	North March Old Dronley Road Dundee DD2 5QT
Customer	Bruce & Sandra Buchan
Prepared by	Graham + Sibbald LLP

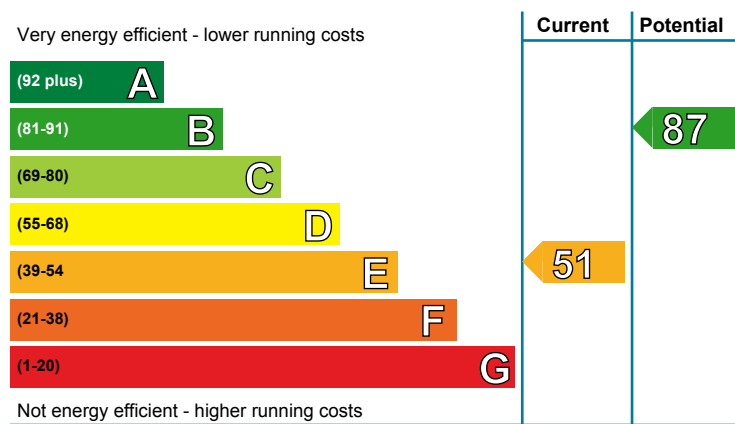
Energy Efficiency Rating

This graph shows the current efficiency of your home, taking into account both energy efficiency and fuel costs. The higher this rating, the lower your fuel bills are likely to be.

Your current rating is **band E (51)**. The average rating for EPCs in Scotland is **band D (61)**.

The potential rating shows the effect of undertaking all of the improvement measures listed within your recommendations report.

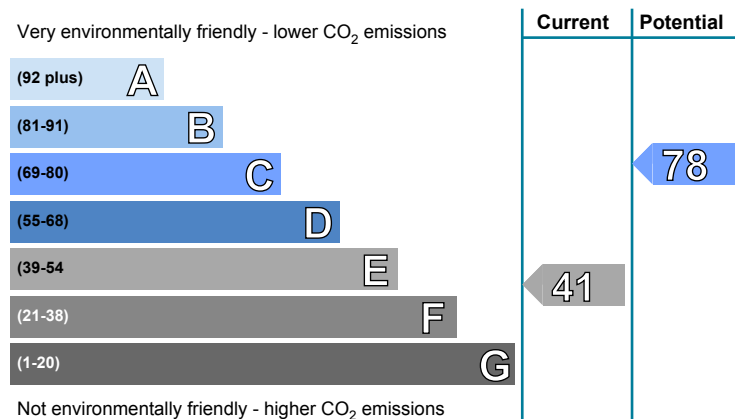
Environmental Impact (CO₂) Rating

This graph shows the effect of your home on the environment in terms of carbon dioxide (CO₂) emissions. The higher the rating, the less impact it has on the environment.
