# Home Report

19 Aboyne Avenue  
Dundee DD4 7TA

Date of Valuation: 12/11/2024

# single survey

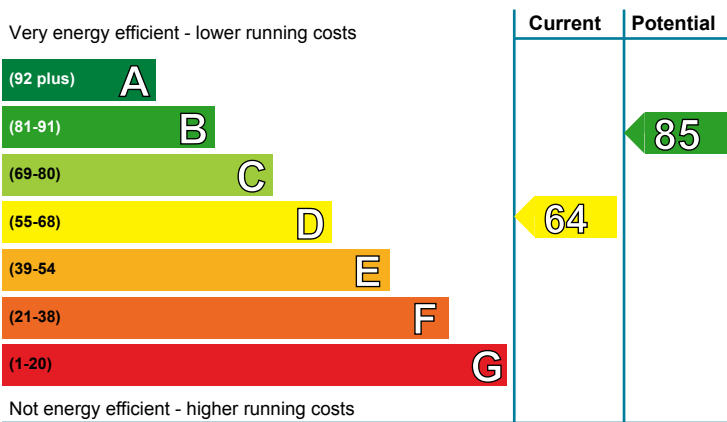
## Energy Efficiency Rating

This graph shows the current efficiency of your home, taking into account both energy efficiency and fuel costs. The higher this rating, the lower your fuel bills are likely to be.

Your current rating is **band D (64)**. The average rating for EPCs in Scotland is **band D (61)**.

The potential rating shows the effect of undertaking all of the improvement measures listed within your recommendations report.

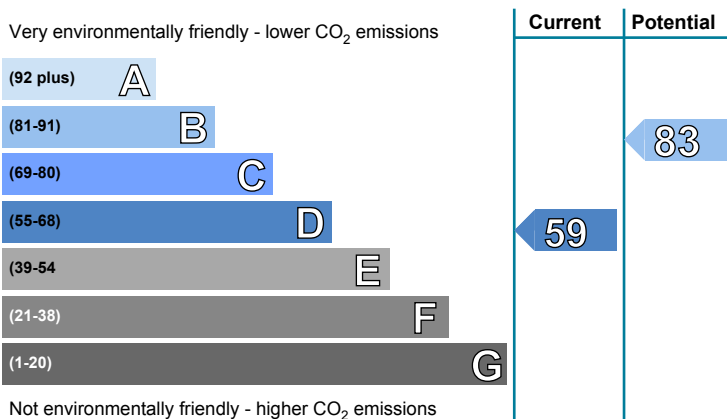
## Environmental Impact (CO<sub>2</sub>) Rating

This graph shows the effect of your home on the environment in terms of carbon dioxide (CO<sub>2</sub>) emissions. The higher the rating, the less impact it has on the environment.
