Home Report

30 Ceres Crescent Broughty Ferry Dundee DD5 3JN

survey report on:

Property address	30 Ceres Crescent Dundee DD5 3JN

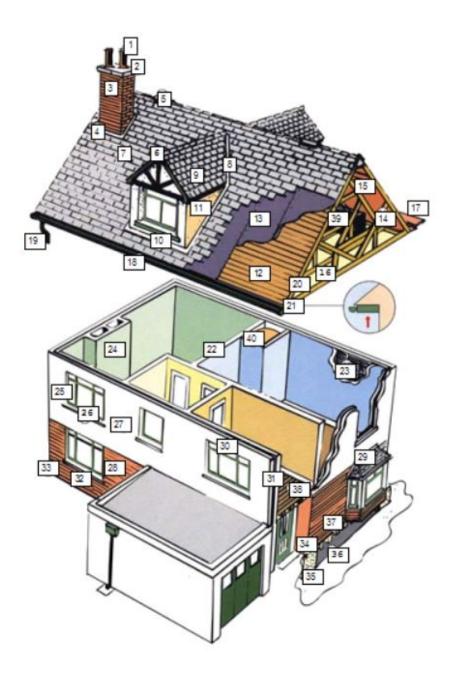
Sectional Diagram showing elements of a typical house

1Chimney pots2Coping stone3Chimney head4Flashing5Ridge ventilation6Ridge board7Slates/tiles8Valley guttering9Dormer projection10Dormer flashing11Dormer cheeks12Sarking13Roof felt14Trusses15Collar16Insulation17Parapet gutter18Eaves guttering19Rainwater downpipe20Verge boards / skews21Soffit boards22Partition wall23Lath / plaster24Chimney breast25Window pointing26Window sills27Rendering28Brickwork / pointing29Bay window30Lintels31Cavity walls / wall ties32Subfloor ventilator33Damp proof course34Base course35Foundations36Solum37Floor joists38Floorboards39Water tank40Hot water tank		_
3Chimney head4Flashing5Ridge ventilation6Ridge board7Slates/tiles8Valley guttering9Dormer projection10Dormer flashing11Dormer cheeks12Sarking13Roof felt14Trusses15Collar16Insulation17Parapet gutter18Eaves guttering19Rainwater downpipe20Verge boards / skews21Soffit boards22Partition wall23Lath / plaster24Chimney breast25Window sills27Rendering28Brickwork / pointing29Bay window30Lintels31Cavity walls / wall ties32Subfloor ventilator33Damp proof course34Base course35Floor joists38Floorboards39Water tank	1	Chimney pots

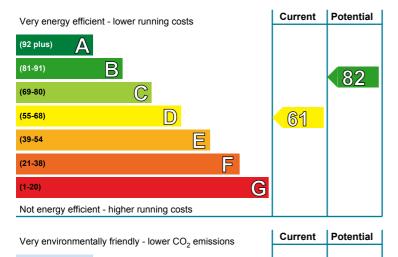
Energy Efficiency Rating

This graph shows the current efficiency of your home, taking into account both energy efficiency and fuel costs. The higher this rating, the lower your fuel bills are likely to be.
