Home Report

53 Kinloch Street Carnoustie DD7 7ER

Property address	
, , , , , , , , , , , , , , , , , , ,	53 Kinloch Street
	Carnoustie
	DD7 7ER

Prepared by	Graham + Sibbald LLP
-------------	----------------------

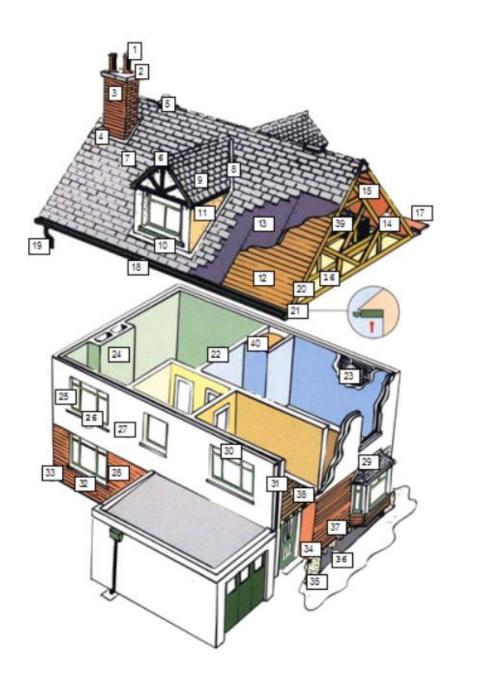
Sectional Diagram showing elements of a typical house

- 1 Chimney pots
- 2 Coping stone
- 3 Chimney head
- 4 Flashing
- 5 Ridge ventilation
- 6 Ridge board
- 7 Slates/tiles
- 8 Valley guttering
- 9 Dormer projection
- 10 Dormer flashing
- 11 Dormer cheeks
- 12 Sarking
- 13 Roof felt
- 14 Trusses
- 15 Collar
- 16 Insulation
- 17 Parapet gutter
- 17 Farapet gutter
- 18 Eaves guttering
- 19 Rainwater downpipe
- 20 Verge boards / skews
- 21 Soffit boards
- 22 Partition wall
- 23 Lath / plaster
- 24 Chimney breast
- 25 Window pointing
- 26 Window sills
- 27 Rendering
- 28 Brickwork / pointing
- 29 Bay window
 - projection
- 30 Lintels
- 31 Cavity walls / wall ties
- 32 Subfloor ventilator
- 33 Damp proof course
- 34 Base course
- 35 Foundations
- 36 Solum
- 37 Floor joists
- 38 Floorboards
- 39 Water tank
- 40 Hot water tank

Reference may be made in this report to some or all of the above component parts of the property. This diagram may assist you in locating and understanding these items.
