Home Report

12 Pitkerro Road Dundee DD4 7DG

Single Survey

Property Address	12 Pitkerro Road Dundee DD4 7DG
Customer	Mark & Rebecca Rodgers
Prepared by	Graham + Sibbald LLP

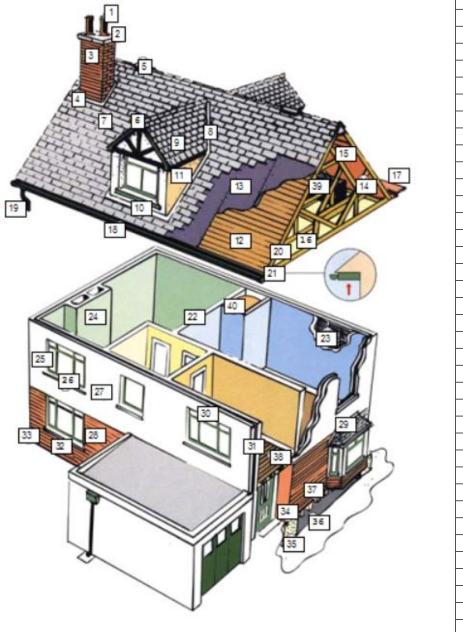
Sectional diagram showing elements of a typical house

_
1	Chimney pots
2	Coping stone
3	Chimney head
4	Flashing
5	Ridge ventilation
6	Ridge board
7	Slates / tiles
8	Valley guttering
9	Dormer projection
10	Dormer flashing
11	Dormer cheeks
12	Sarking
13	Roof felt
14	Trusses
15	Collar
16	Insulation
17	Parapet gutter
18	Eaves guttering
19	Rainwater downpipe
20	Verge boards / skews
21	Soffit boards
22	Partition wall
23	Lath / plaster
24	Chimney breast
25	Window pointing
26	Window sills
27	Rendering
28	Brickwork / pointing
29	Bay window projection
30	Lintels
31	Cavity walls / wall ties
32	Subfloor ventilator
33	Damp proof course
34	Base course
35	Foundations
36	Solum
37	Floor joists
38	Floorboards
39	Water tank
40	Hot water tank

Reference may be made in this report to some or all of the above component parts of the property. This diagram may assist you in locating and understanding these items.
