Home Report

8B Bingham Terrace
Dundee DD4 7HH

Single Survey

Property Address	8B Bingham Terrace Dundee DD4 7HH
Customer	John Hodge
Prepared by	Graham + Sibbald LLP
Date of Inspection	06/01/2025

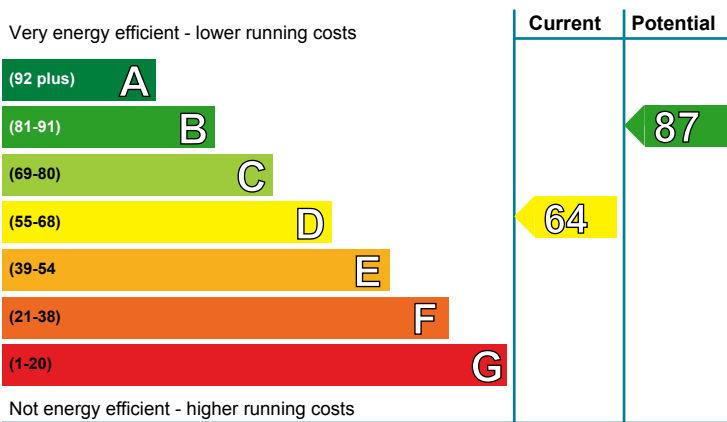
Energy Efficiency Rating

This graph shows the current efficiency of your home, taking into account both energy efficiency and fuel costs. The higher this rating, the lower your fuel bills are likely to be.

Your current rating is **band D (64)**. The average rating for EPCs in Scotland is **band D (61)**.

The potential rating shows the effect of undertaking all of the improvement measures listed within your recommendations report.
