# Home Report

120 Camphill Road  
Broughty Ferry Dundee DD5 2ND

# Single Survey

<b>Property Address</b>	120 Camphill Road Dundee DD5 2ND
<b>Customer</b>	Ms K Smernicki & Mr P Smernicki
<b>Prepared by</b>	Graham + Sibbald LLP
<b>Date of Inspection</b>	23/01/2025

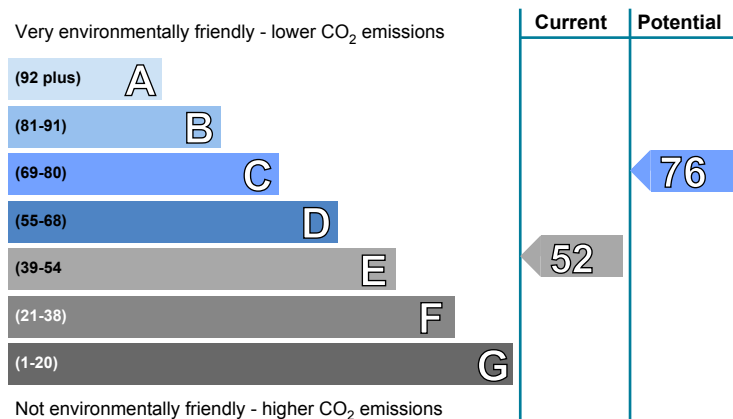
## Environmental Impact (CO<sub>2</sub>) Rating

This graph shows the effect of your home on the environment in terms of carbon dioxide (CO<sub>2</sub>) emissions. The higher the rating, the less impact it has on the environment.
