# Home Report

115 Pitkerro Road  
Dundee DD4 7EE

# Single Survey

<b>Property Address</b>	115 Pitkerro Road Dundee DD4 7EE
<b>Customer</b>	Chloe Anderson & David McVeigh
<b>Prepared by</b>	Graham + Sibbald LLP
<b>Date of Inspection</b>	06/02/2025

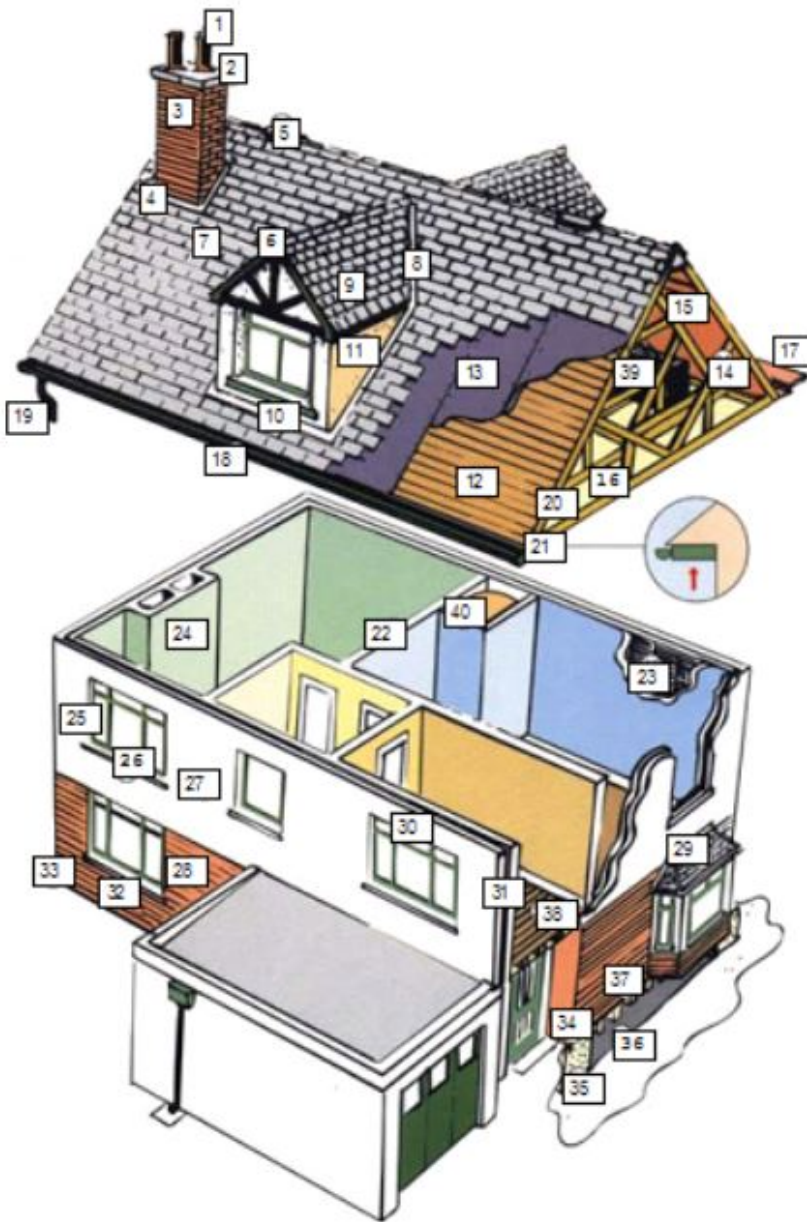
Sectional diagram showing elements of a typical house

1	Chimney pots
2	Coping stone
3	Chimney head
4	Flashing
5	Ridge ventilation
6	Ridge board
7	Slates / tiles
8	Valley guttering
9	Dormer projection
10	Dormer flashing
11	Dormer cheeks
12	Sarking
13	Roof felt
14	Trusses
15	Collar
16	Insulation
17	Parapet gutter
18	Eaves guttering
19	Rainwater downpipe
20	Verge boards / skews
21	Soffit boards
22	Partition wall
23	Lath / plaster
24	Chimney breast
25	Window pointing
26	Window sills
27	Rendering
28	Brickwork / pointing
29	Bay window projection
30	Lintels
31	Cavity walls / wall ties
32	Subfloor ventilator
33	Damp proof course
34	Base course
35	Foundations
36	Solum
37	Floor joists
38	Floorboards
39	Water tank
40	Hot water tank

Reference may be made in this report to some or all of the above component parts of the property. This diagram may assist you in locating and understanding these items.

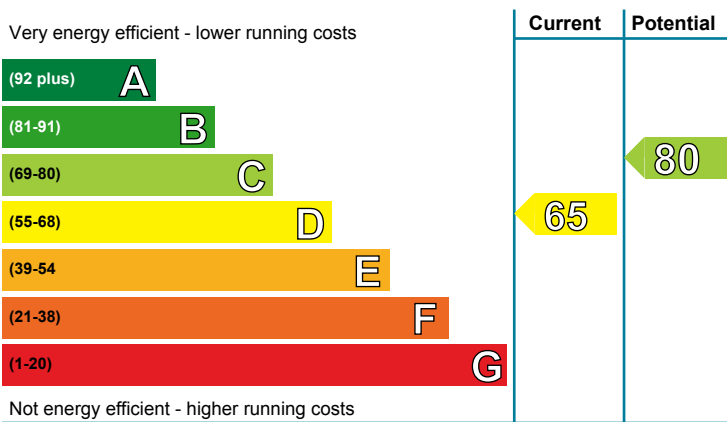
## Energy Efficiency Rating

This graph shows the current efficiency of your home, taking into account both energy efficiency and fuel costs. The higher this rating, the lower your fuel bills are likely to be.

Your current rating is **band D (65)**. The average rating for EPCs in Scotland is **band D (61)**.

The potential rating shows the effect of undertaking all of the improvement measures listed within your recommendations report.

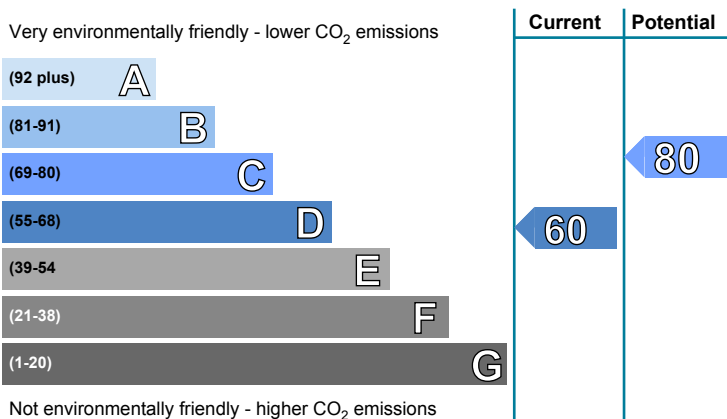
## Environmental Impact (CO<sub>2</sub>) Rating

This graph shows the effect of your home on the environment in terms of carbon dioxide (CO<sub>2</sub>) emissions. The higher the rating, the less impact it has on the environment.
