# Home Report

60 Seymour Street  
Dundee DD2 1HB

# Single Survey

<b>Property Address</b>	60 Seymour Street Dundee DD2 1HB
<b>Customer</b>	Dr A Williams & Dr H Williams
<b>Prepared by</b>	Graham + Sibbald LLP
<b>Date of Inspection</b>	06/02/2025

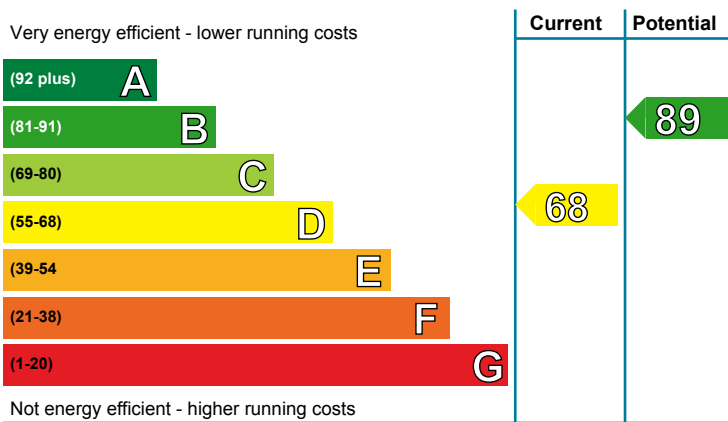
## Energy Efficiency Rating

This graph shows the current efficiency of your home, taking into account both energy efficiency and fuel costs. The higher this rating, the lower your fuel bills are likely to be.

Your current rating is **band D (68)**. The average rating for EPCs in Scotland is **band D (61)**.

The potential rating shows the effect of undertaking all of the improvement measures listed within your recommendations report.

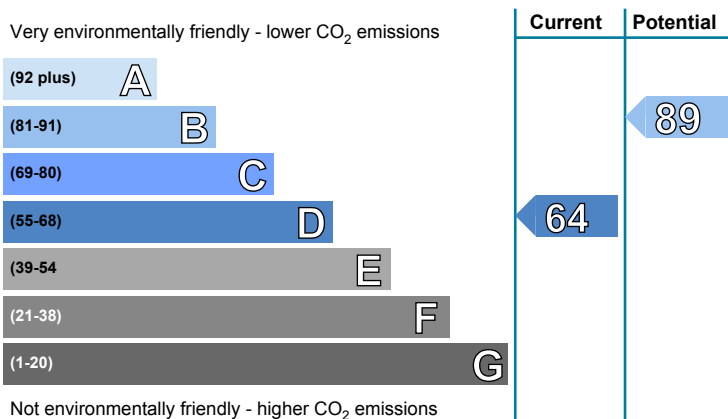
## Environmental Impact (CO<sub>2</sub>) Rating

This graph shows the effect of your home on the environment in terms of carbon dioxide (CO<sub>2</sub>) emissions. The higher the rating, the less impact it has on the environment.
