Home Report

16D Shaftesbury Place
Dundee DD2 1JX

Single Survey

Property Address	16D Shaftesbury Place Dundee DD2 1JX
Customer	Michael Dunlop & Hannah Hamilton
Prepared by	Graham + Sibbald LLP
Date of Inspection	18/02/2025

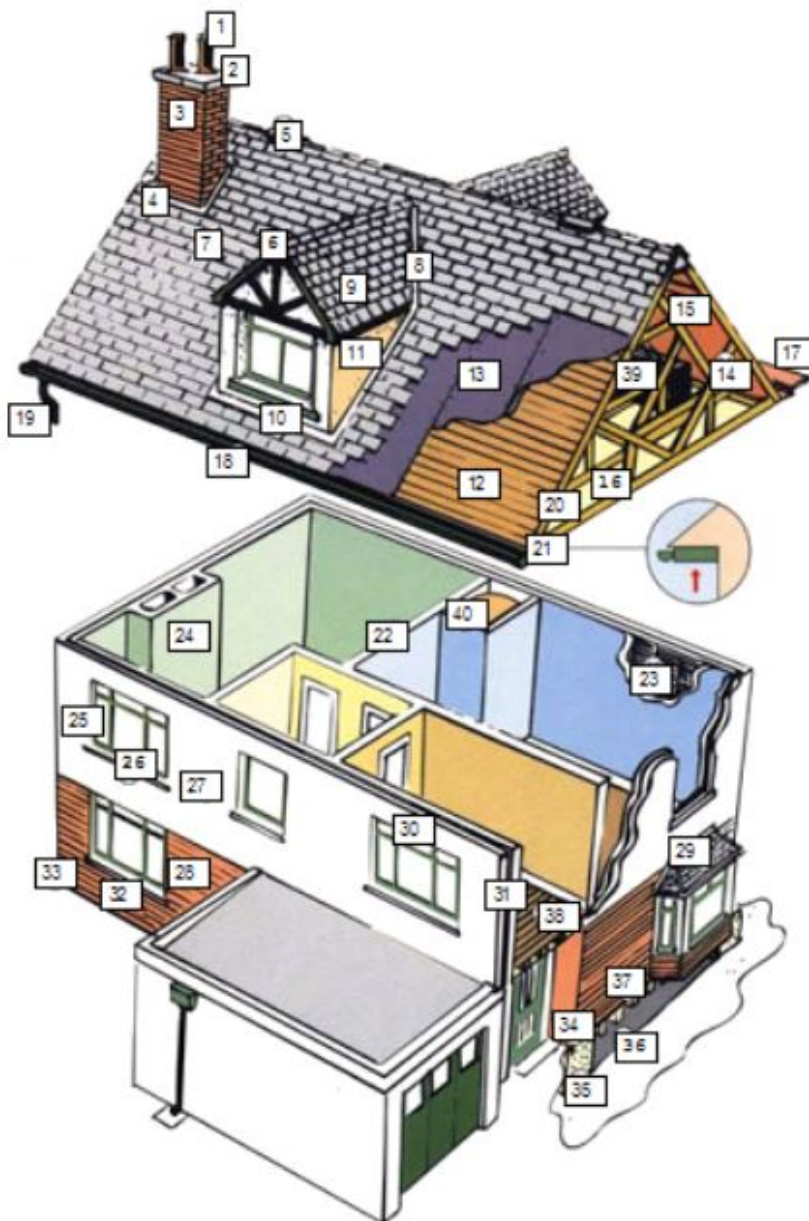
Sectional diagram showing elements of a typical house

1	Chimney pots
2	Coping stone
3	Chimney head
4	Flashing
5	Ridge ventilation
6	Ridge board
7	Slates / tiles
8	Valley guttering
9	Dormer projection
10	Dormer flashing
11	Dormer cheeks
12	Sarking
13	Roof felt
14	Trusses
15	Collar
16	Insulation
17	Parapet gutter
18	Eaves guttering
19	Rainwater downpipe
20	Verge boards / skews
21	Soffit boards
22	Partition wall
23	Lath / plaster
24	Chimney breast
25	Window pointing
26	Window sills
27	Rendering
28	Brickwork / pointing
29	Bay window projection
30	Lintels
31	Cavity walls / wall ties
32	Subfloor ventilator
33	Damp proof course
34	Base course
35	Foundations
36	Solum
37	Floor joists
38	Floorboards
39	Water tank
40	Hot water tank

Reference may be made in this report to some or all of the above component parts of the property. This diagram may assist you in locating and understanding these items.

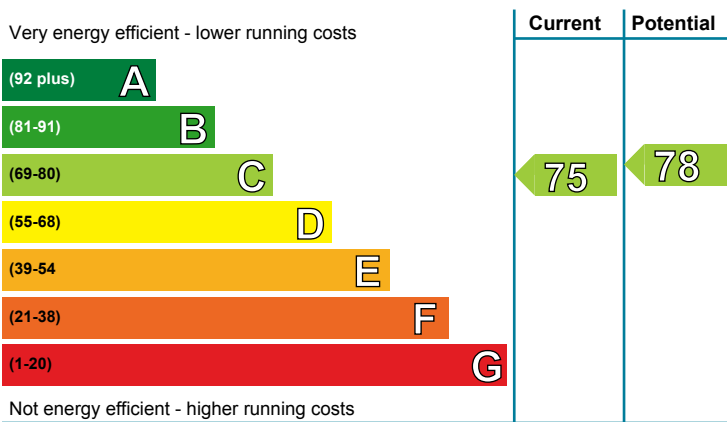
Energy Efficiency Rating

This graph shows the current efficiency of your home, taking into account both energy efficiency and fuel costs. The higher this rating, the lower your fuel bills are likely to be.

Your current rating is **band C (75)**. The average rating for EPCs in Scotland is **band D (61)**.

The potential rating shows the effect of undertaking all of the improvement measures listed within your recommendations report.

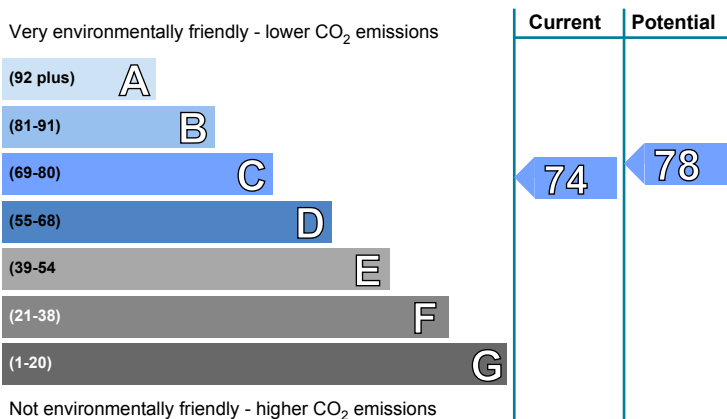
Environmental Impact (CO₂) Rating

This graph shows the effect of your home on the environment in terms of carbon dioxide (CO₂) emissions. The higher the rating, the less impact it has on the environment.
