Home Report

9 Hazel Drive Dundee DD2 1QQ

Single Survey

| Description | The subjects comprise a semi-detached two storey villa. |

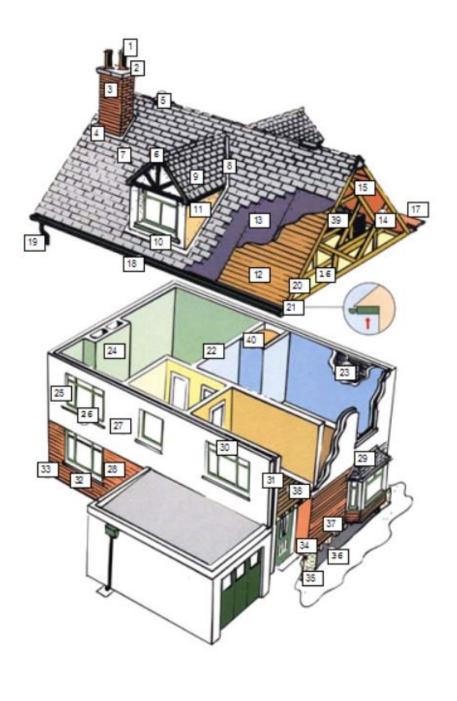
Sectional diagram showing elements of a typical house

Chimney pots 1 Coping stone 2 3 Chimney head Flashing 4 Ridge ventilation 5 Ridge board 6 Slates / tiles 7 Valley guttering 8 9 Dormer projection Dormer flashing 10 Dormer cheeks 11 12 Sarking 13 Roof felt Trusses 14 Collar 15 Insulation 16 Parapet gutter 17 18 Eaves guttering Rainwater downpipe 19 20 Verge boards / skews 21 Soffit boards Partition wall 22 23 Lath / plaster 24 Chimney breast Window pointing 25 Window sills 26 Rendering 27 Brickwork / pointing 28 Bay window projection 29 Lintels 30 Cavity walls / wall ties 31 Subfloor ventilator 32 33 Damp proof course Base course 34 Foundations 35 Solum 36 Floor joists 37 Floorboards 38 Water tank 39 Hot water tank 40

Reference may be made in this report to some or all of the above component parts of the property. This diagram may assist you in locating and understanding these items.
