**HOME**  
report

SINGLE SURVEY  
ENERGY REPORT  
PROPERTY QUESTIONNAIRE  
VALUATION REPORT

# Single Survey

<b>Property Address</b>	3 Camperdown Street Broughty Ferry Dundee DD5 3AG
<b>Customer</b>	Mr J Batchelor
<b>Date of Inspection</b>	25/02/2025
<b>Prepared by</b>	Joseph Dowie Harvey Donaldson & Gibson Chartered Surveyors

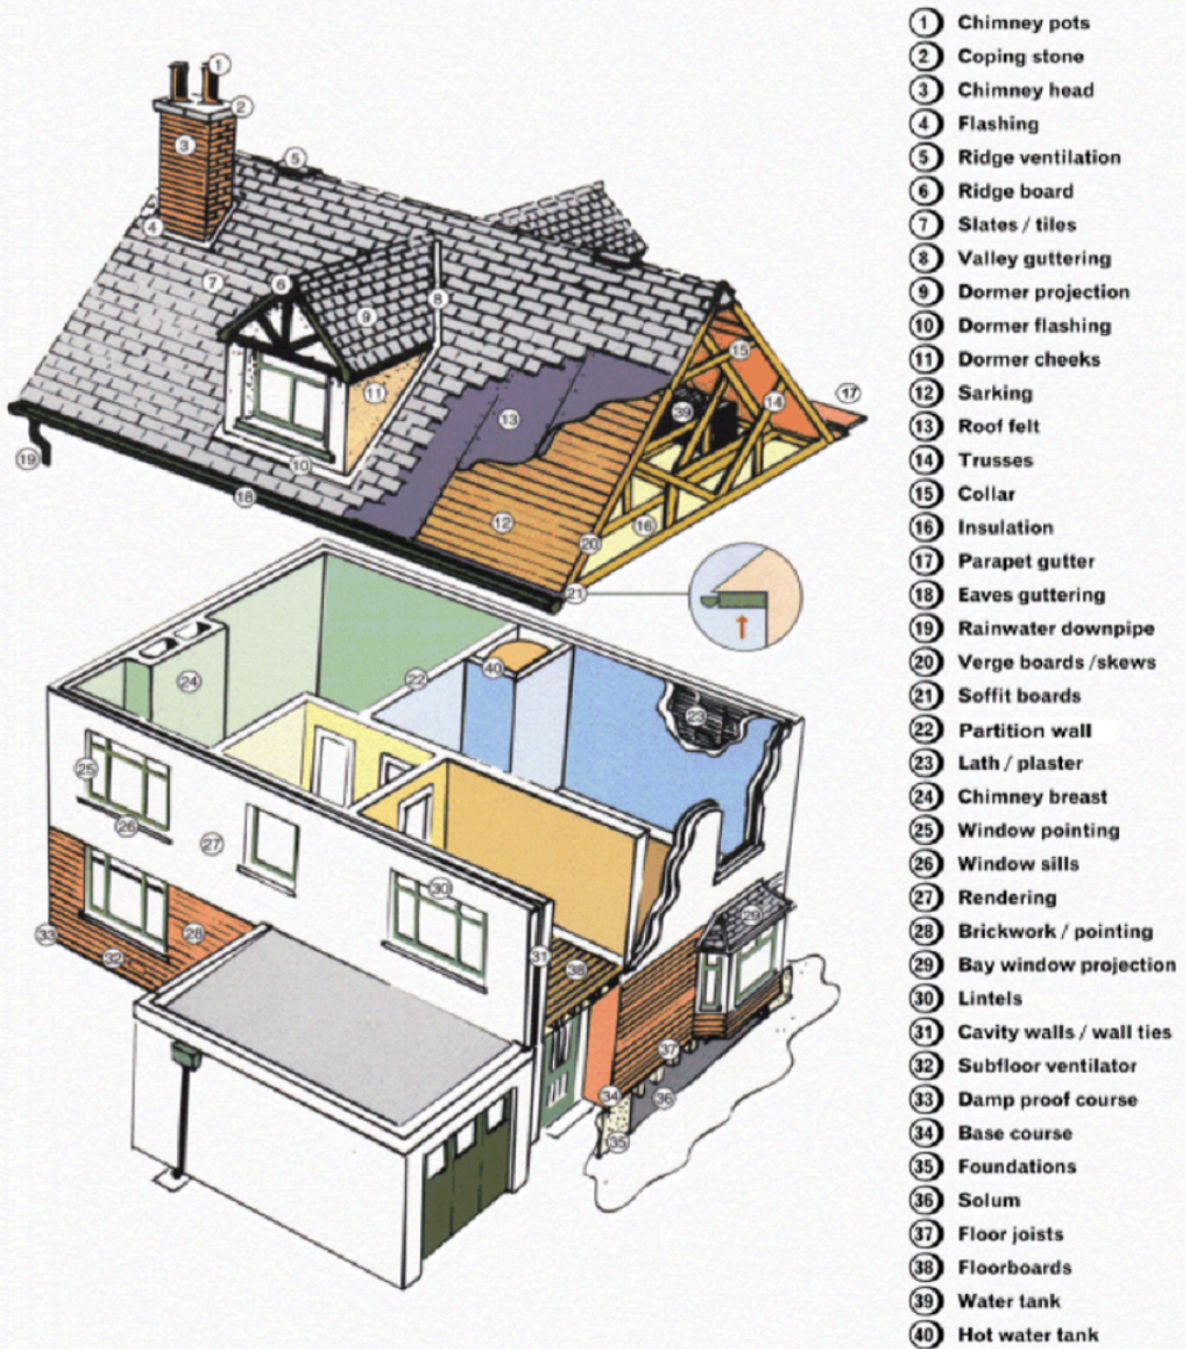
## Sectional Diagram showing elements of a typical house

Reference may be made in this report to some or all of the above component parts of the property. This diagram may assist you in locating and understanding these items.

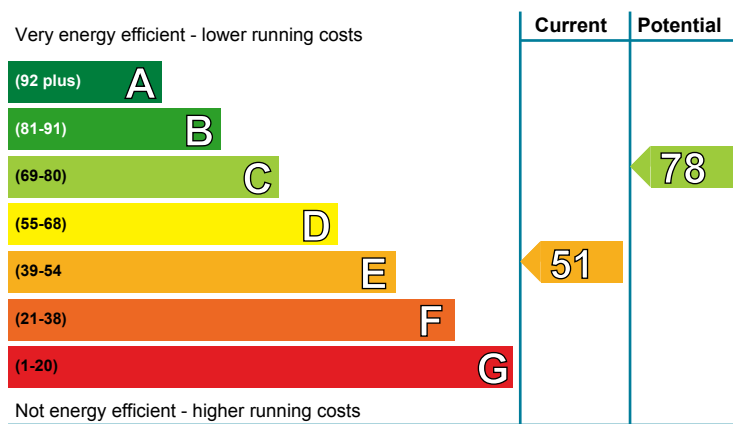
## Energy Efficiency Rating

This graph shows the current efficiency of your home, taking into account both energy efficiency and fuel costs. The higher this rating, the lower your fuel bills are likely to be.

Your current rating is **band E (51)**. The average rating for EPCs in Scotland is **band D (61)**.

The potential rating shows the effect of undertaking all of the improvement measures listed within your recommendations report.

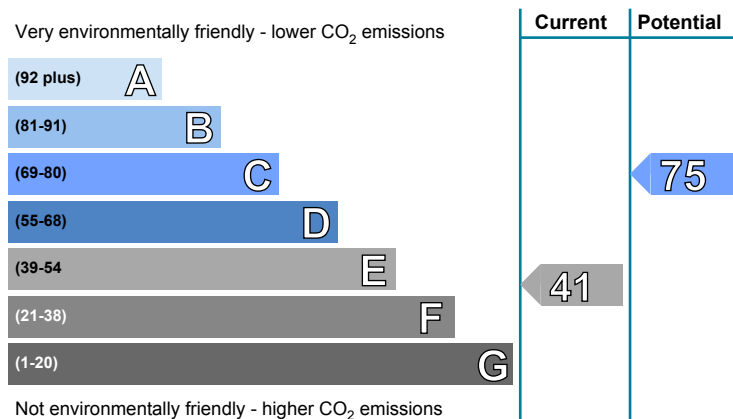
## Environmental Impact (CO<sub>2</sub>) Rating

This graph shows the effect of your home on the environment in terms of carbon dioxide (CO<sub>2</sub>) emissions. The higher the rating, the less impact it has on the environment.
