**HOME**  
report

SINGLE SURVEY  
ENERGY REPORT  
PROPERTY QUESTIONNAIRE  
VALUATION REPORT

<b>Property Address</b>	53 Monifieth Road Broughty Ferry Dundee DD5 2RW
<b>Customer</b>	Mr N Culross
<b>Date of Inspection</b>	07/03/2025
<b>Prepared by</b>	Joseph Dowie Harvey Donaldson & Gibson Chartered Surveyors

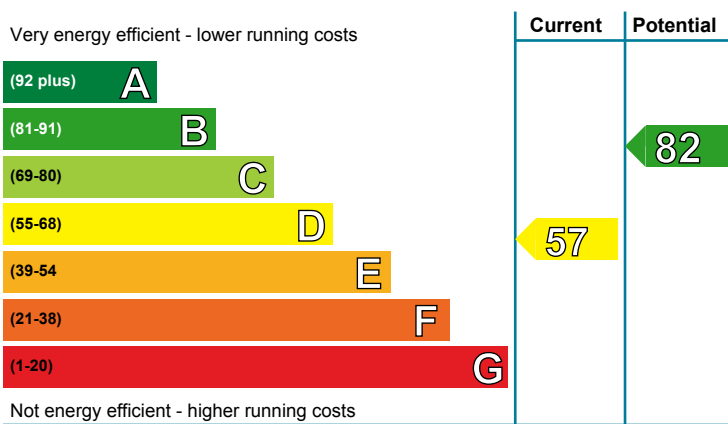
## Energy Efficiency Rating

This graph shows the current efficiency of your home, taking into account both energy efficiency and fuel costs. The higher this rating, the lower your fuel bills are likely to be.

Your current rating is **band D (57)**. The average rating for EPCs in Scotland is **band D (61)**.

The potential rating shows the effect of undertaking all of the improvement measures listed within your recommendations report.

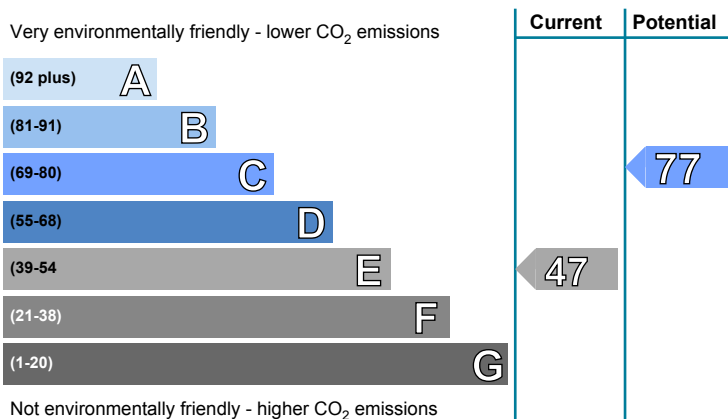
## Environmental Impact (CO<sub>2</sub>) Rating

This graph shows the effect of your home on the environment in terms of carbon dioxide (CO<sub>2</sub>) emissions. The higher the rating, the less impact it has on the environment.
