Home Report

54 Bridge Street Montrose DD10 8AF

Single Survey

Property Address	54 Bridge Street Montrose DD10 8AF
Customer	Ryan Daly & Alanah Daly
Prepared by	Graham + Sibbald LLP
Date of Inspection	28/02/2025

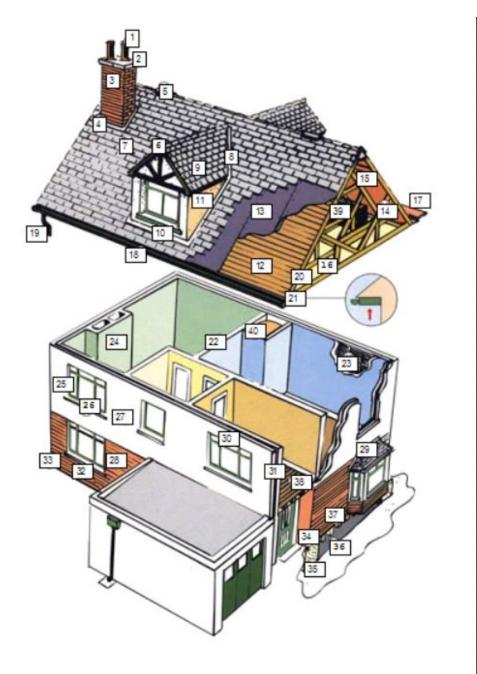
Sectional diagram showing elements of a typical house

_	.
1	Chimney pots
2	Coping stone
3	Chimney head
4	Flashing
5	Ridge ventilation
6	Ridge board
7	Slates / tiles
8	Valley guttering
9	Dormer projection
10	Dormer flashing
11	Dormer cheeks
12	Sarking
13	Roof felt
14	Trusses
15	Collar
16	Insulation
17	Parapet gutter
18	Eaves guttering
19	Rainwater downpipe
20	Verge boards / skews
21	Soffit boards
22	Partition wall
23	Lath / plaster
24	Chimney breast
25	Window pointing
26	Window sills
27	Rendering
28	Brickwork / pointing
29	Bay window projection
30	Lintels
31	Cavity walls / wall ties
32	Subfloor ventilator
33	Damp proof course
34	Base course
35	Foundations
36	Solum
37	Floor joists
38	Floorboards
39	Water tank
40	Hot water tank

Reference may be made in this report to some or all of the above component parts of the property. This diagram may assist you in locating and understanding these items.
