Home Report

1 Bridgend Of Carse Errol PH2 7TB

Single Survey

Survey report on:

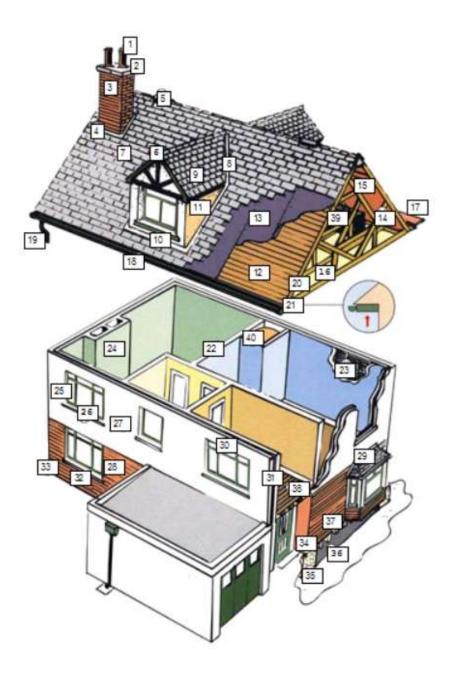
Sectional diagram showing elements of a typical house

Chimney pots 1 2 Coping stone 3 Chimney head 4 Flashing 5 **Ridge ventilation** 6 **Ridge board** 7 Slates / tiles 8 Valley guttering 9 Dormer projection 10 Dormer flashing Dormer cheeks 11 12 Sarking Roof felt 13 Trusses 14 15 Collar 16 Insulation 17 Parapet gutter 18 Eaves guttering 19 Rainwater downpipe 20 Verge boards / skews 21 Soffit boards Partition wall 22 23 Lath / plaster 24 Chimney breast 25 Window pointing Window sills 26 27 Rendering 28 Brickwork / pointing 29 Bay window projection 30 Lintels 31 Cavity walls / wall ties 32 Subfloor ventilator 33 Damp proof course 34 Base course 35 Foundations 36 Solum Floor joists 37 38 Floorboards 39 Water tank 40 Hot water tank

Reference may be made in this report to some or all of the above component parts of the property. This diagram may assist you in locating and understanding these items.
