Home Report

132 Balgillo Road Broughty Ferry Dundee DD5 3EB

Single Survey

Property Address	132 Balgillo Road Dundee DD5 3EB
Customer	Louise Hodgson
Prepared by	Graham + Sibbald LLP
Date of Inspection	18/03/2025

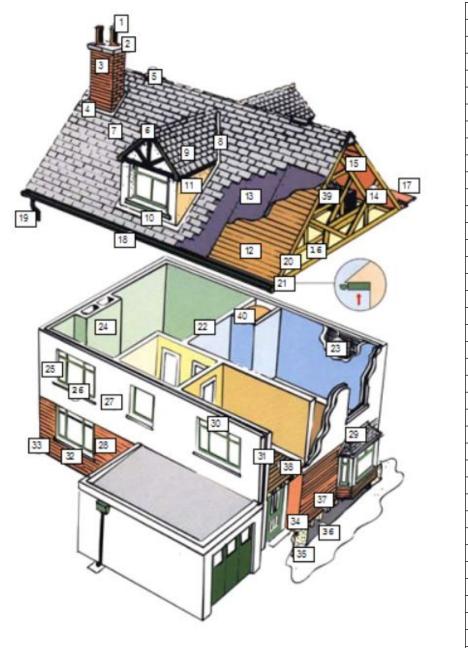
Sectional diagram showing elements of a typical house

_
1	Chimney pots
2	Coping stone
3	Chimney head
4	Flashing
5	Ridge ventilation
6	Ridge board
7	Slates / tiles
8	Valley guttering
9	Dormer projection
10	Dormer flashing
11	Dormer cheeks
12	Sarking
13	Roof felt
14	Trusses
15	Collar
16	Insulation
17	Parapet gutter
18	Eaves guttering
19	Rainwater downpipe
20	Verge boards / skews
21	Soffit boards
22	Partition wall
23	Lath / plaster
24	Chimney breast
25	Window pointing
26	Window sills
27	Rendering
28	Brickwork / pointing
29	Bay window projection
30	Lintels
31	Cavity walls / wall ties
32	Subfloor ventilator
33	Damp proof course
34	Base course
35	Foundations
36	Solum
37	Floor joists
38	Floorboards
39	Water tank
40	Hot water tank

Reference may be made in this report to some or all of the above component parts of the property. This diagram may assist you in locating and understanding these items.
