Home Report

19 Americanmuir Road Dundee DD3 9AA

Date of Valuation: 07/04/2025

Single Survey

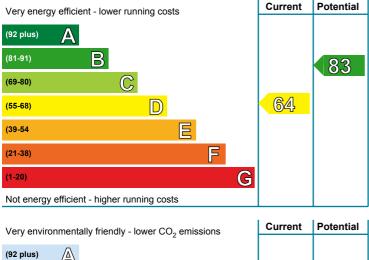
Energy Efficiency Rating

(92 plus) A (81-91) B (69-80) C (55-68) D (39-54 E (21-38) F (1-20) G
