Home Report

Scottish
Single Survey

Property address	23 Angus Drive Monifieth Dundee DD5 4UA
Customer	Erin Robertson
Customer address	23 Angus Drive Monifieth Dundee DD5 4UA
Prepared by	Shepherd Chartered Surveyors
Date of inspection	16/05/2025

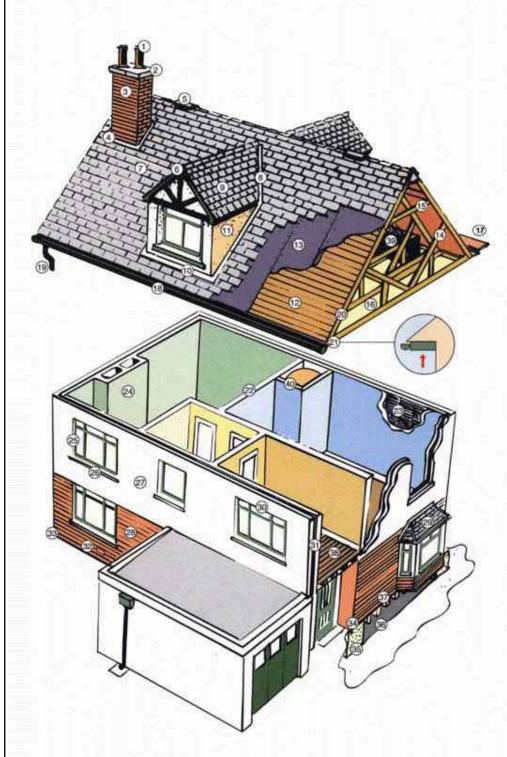
Sectional Diagram showing elements of a typical house

Reference may be made in this report to some or all of the above component parts of the property. This diagram may assist you in locating and understanding these items.

- 1) Chimney pots
- 2) Coping stone
- 3 Chimney head
- (4) Flashing
- 5) Ridge ventilation
- 6 Ridge board
- (7) Slates / tiles
- 8 Valley guttering
- 9 Dormer projection
- 10 Dormer flashing
- 11 Dormer cheeks
- 12) Sarking
- 13) Roof felt
- (14) Trusses
- (15) Collar
- (16) Insulation
- (17) Parapet gutter
- 18) Eaves guttering
- (19) Rainwater downpipe
- 20) Verge boards/skews
- 21) Soffit boards
- 22) Partition wall
- 23) Lath / plaster
- 24) Chimney breast
- 25) Window pointing
- 26) Window sills
- 27) Rendering
- (28) Brickwork / pointing
- 29 Bay window projection
- (30) Lintels
- (31) Cavity walls / wall ties
- 32) Subfloor ventilator
- (33) Damp proof course
- (34) Base course
- 35) Foundations
- 36) Solum
- 37) Floor joists
- 38) Floorboards
- 9) Water tank
- 40) Hot water tank
