# Home Report

4 School Wynd  
Tayport DD6 9DD

# Single Survey

Property Address	4 School Wynd Tayport DD6 9DD
Customer	Mr Euan Bright
Prepared by	Graham + Sibbald LLP
Date of Inspection	15/05/2025

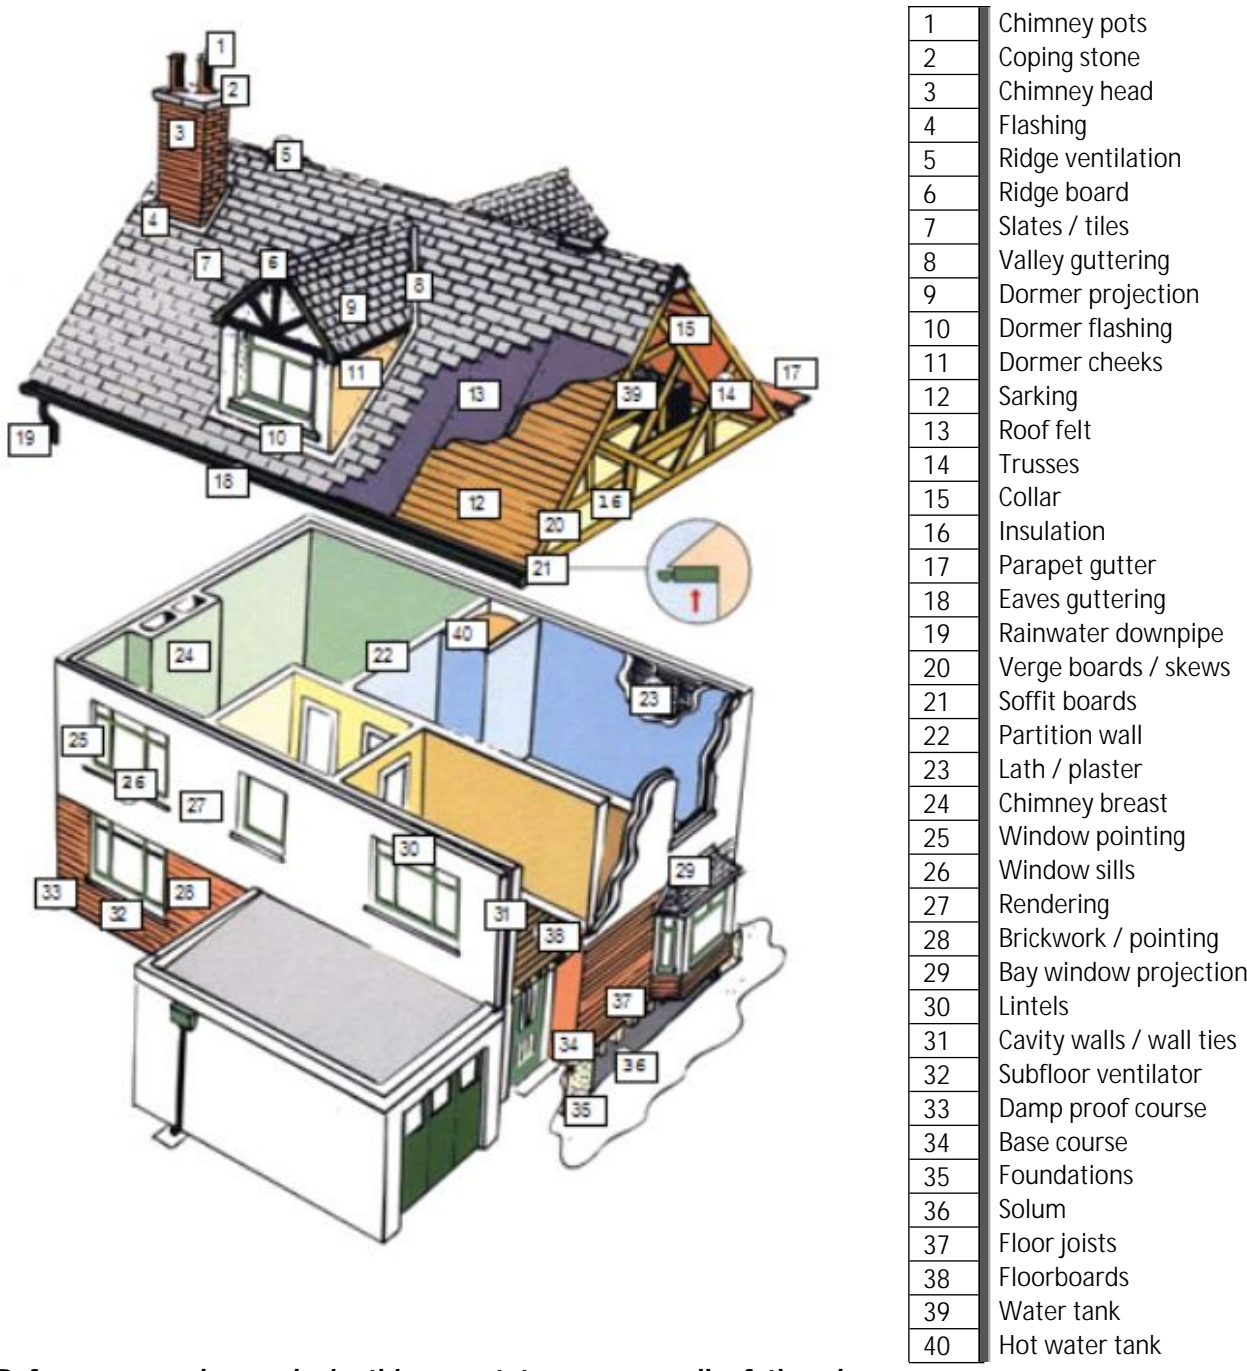
Sectional diagram showing elements of a typical house

Reference may be made in this report to some or all of the above component parts of the property. This diagram may assist you in locating and understanding these items.
