Home Report

126 Strathern Road Broughty Ferry Dundee DD5 1JW

Single Survey

Description The subjects comprise a detached two storey villa.
--

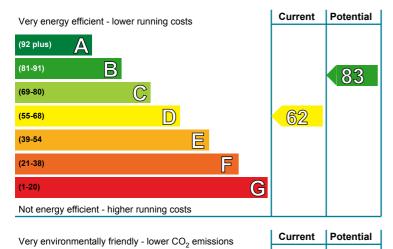
Energy Efficiency Rating

This graph shows the current efficiency of your home, taking into account both energy efficiency and fuel costs. The higher this rating, the lower your fuel bills are likely to be.
