Home Report

2 Nursery Road Broughty Ferry Dundee DD5 3DU

Single Survey

Property Address	2 Nursery Road Dundee DD5 3DU
Customer	Liam Boyle & Poppy Bowman
Prepared by	Graham + Sibbald LLP
Date of Inspection	24/04/2025

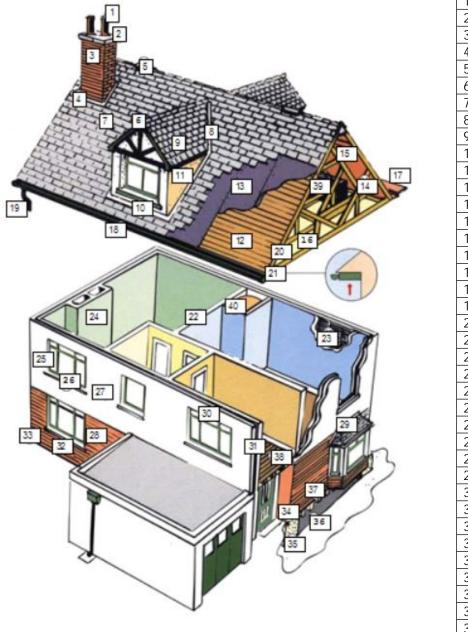
Sectional diagram showing elements of a typical house

1	Chimney pots
2	Coping stone
3	Chimney head
4	Flashing
5	Ridge ventilation
6	Ridge board
7	Slates / tiles
8	Valley guttering
9	Dormer projection
10	Dormer flashing
11	Dormer cheeks
12	Sarking
13	Roof felt
14	Trusses
15	Collar
16	Insulation
17	Parapet gutter
18	Eaves guttering
19	Rainwater downpipe
20	Verge boards / skews
21	Soffit boards
22	Partition wall
23	Lath / plaster
24	Chimney breast
25	Window pointing
26	Window sills
27	Rendering
28	Brickwork / pointing
29	Bay window projection
30	Lintels
31	Cavity walls / wall ties
32	Subfloor ventilator
33	Damp proof course
34	Base course
35	Foundations
36	Solum
37	Floor joists
38	Floorboards
39	Water tank
40	Hot water tank

Reference may be made in this report to some or all of the above component parts of the property. This diagram may assist you in locating and understanding these items.
