# Home Report

2/L 27 Baxter Park Terrace  
Dundee DD4 6NR

# Single Survey

Property Address	2/L 27 Baxter Park Terrace Dundee DD4 6NR
Customer	Alistair Mclean
Prepared by	Graham + Sibbald LLP
Date of Inspection	19/05/2025

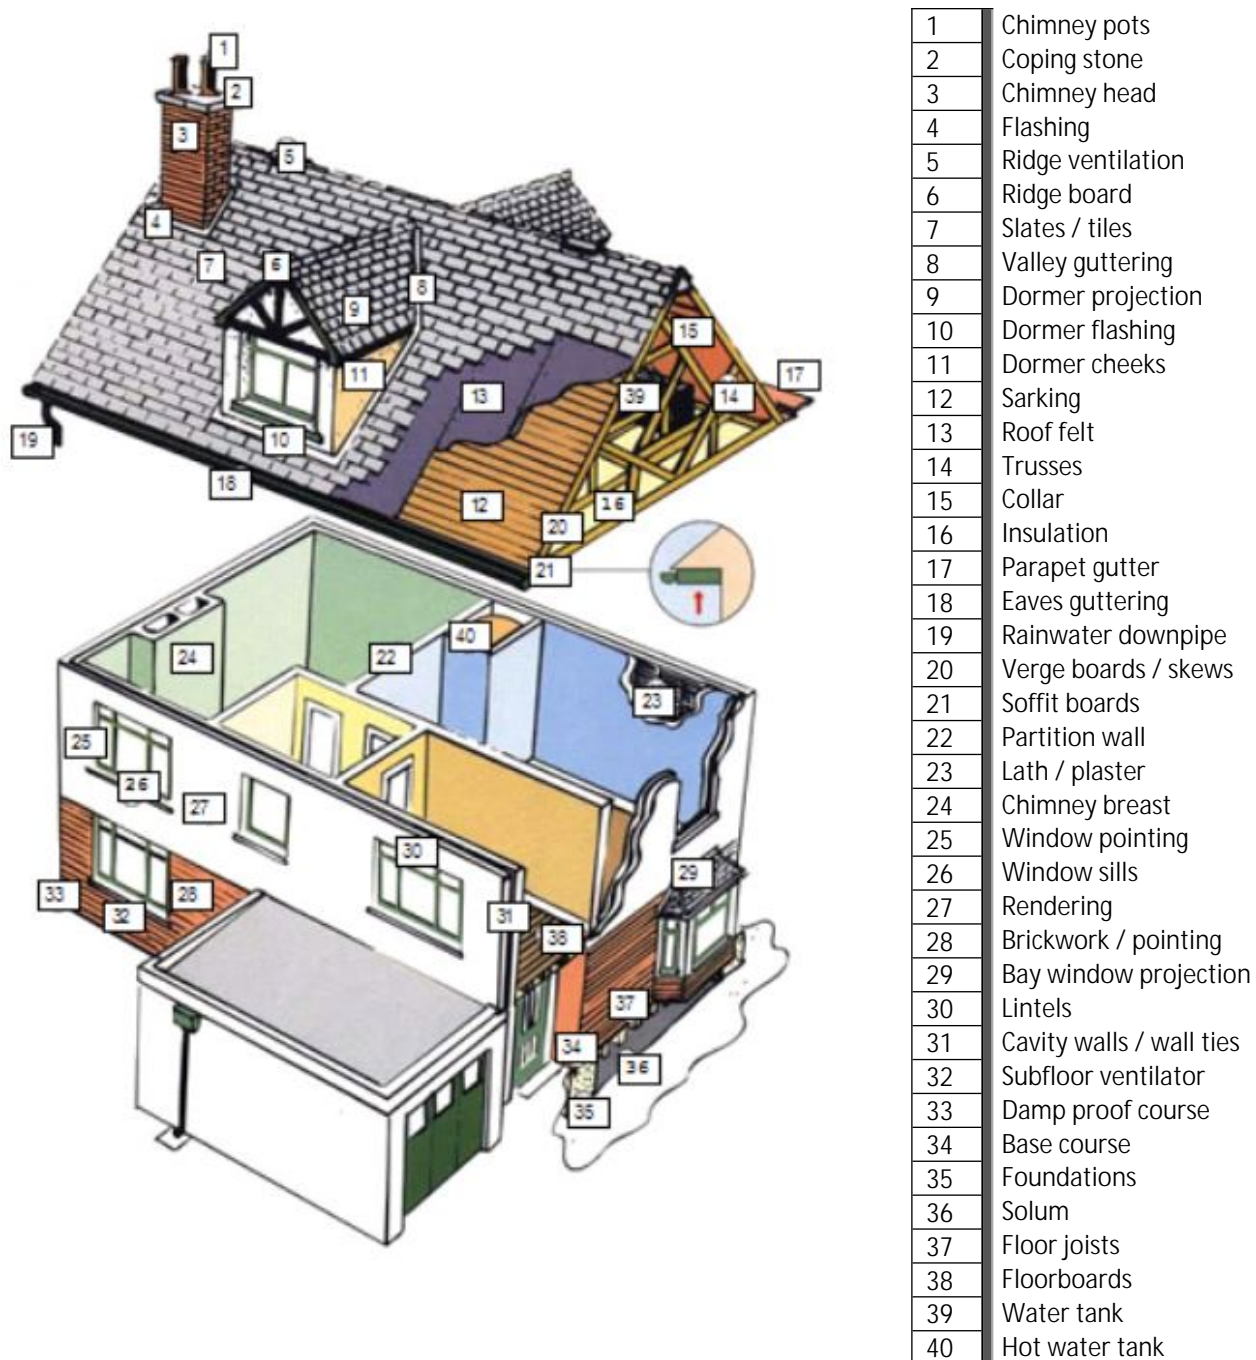
## Sectional diagram showing elements of a typical house

Reference may be made in this report to some or all of the above component parts of the property. This diagram may assist you in locating and understanding these items.
