# Home Report

36 Lammerton Terrace  
Dundee DD4 7BL

# Single Survey

| <b>Description</b> | The subjects comprise a semi-detached two storey villa. |

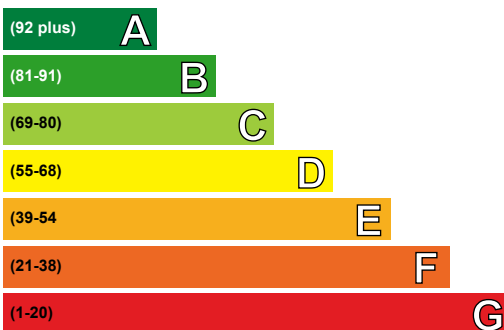
\* based upon the cost of energy for heating, hot water, lighting and ventilation, calculated using standard assumptions

Very energy efficient - lower running costs

Not energy efficient - higher running costs

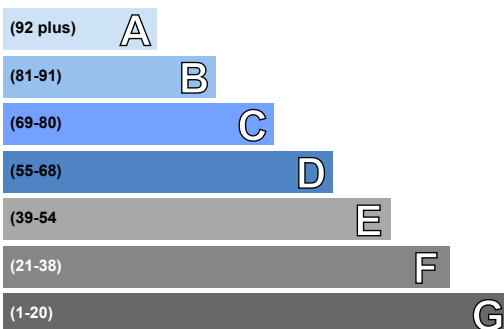
Very environmentally friendly - lower CO<sub>2</sub> emissions

Not environmentally friendly - higher CO<sub>2</sub> emissions
