Home Report

28 Rosewell Road Maryton Kirriemuir DD8 5PX

Single Survey

Property Address	28 Rosewell Road Kirriemuir DD8 5PX
Customer	Blackadders Trustees
Prepared by	Graham + Sibbald LLP
Date of Inspection	27/05/2025

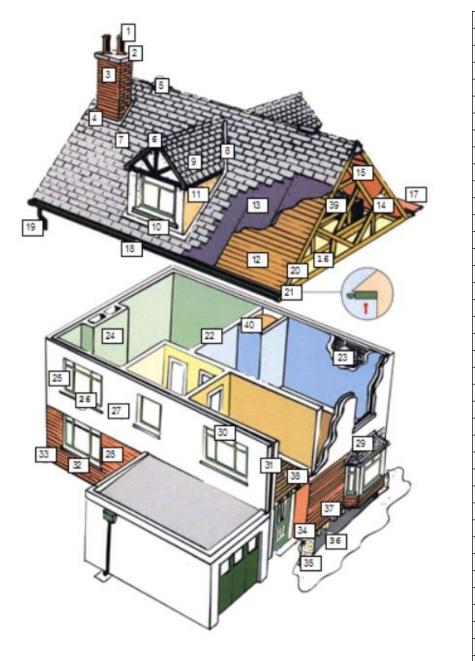
Sectional diagram showing elements of a typical house

_
1	Chimney pots
2	Coping stone
3	Chimney head
4	Flashing
5	Ridge ventilation
6	Ridge board
7	Slates / tiles
8	Valley guttering
9	Dormer projection
10	Dormer flashing
11	Dormer cheeks
12	Sarking
13	Roof felt
14	Trusses
15	Collar
16	Insulation
17	Parapet gutter
18	Eaves guttering
19	Rainwater downpipe
20	Verge boards / skews
21	Soffit boards
22	Partition wall
23	Lath / plaster
24	Chimney breast
25	Window pointing
26	Window sills
27	Rendering
28	Brickwork / pointing
29	Bay window projection
30	Lintels
31	Cavity walls / wall ties
32	Subfloor ventilator
33	Damp proof course
34	Base course
35	Foundations
36	Solum
37	Floor joists
38	Floorboards
39	Water tank
40	Hot water tank

Reference may be made in this report to some or all of the above component parts of the property. This diagram may assist you in locating and understanding these items.
