Home Report

Taypark Flat 13 30 Dundee Road Broughty Ferry Dundee DD5 1LX

Survey report on:

Property Address	Taypark Flat 13 30 Dundee Road
	Dundee DD5 1LX

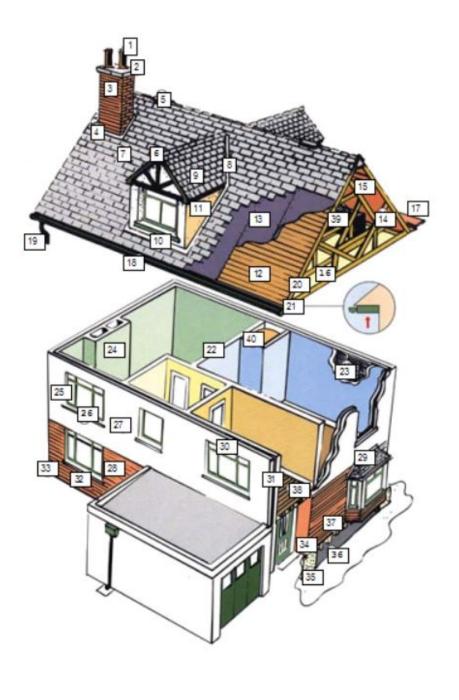
Sectional diagram showing elements of a typical house

Chimney pots 1 Coping stone 2 3 Chimney head Flashing 4 Ridge ventilation 5 Ridge board 6 Slates / tiles 7 Valley guttering 8 9 Dormer projection Dormer flashing 10 Dormer cheeks 11 12 Sarking 13 Roof felt Trusses 14 Collar 15 Insulation 16 Parapet gutter 17 18 Eaves guttering Rainwater downpipe 19 Verge boards / skews 20 Soffit boards 21 Partition wall 22 23 Lath / plaster 24 Chimney breast Window pointing 25 Window sills 26 Rendering 27 Brickwork / pointing 28 29 Bay window projection Lintels 30 Cavity walls / wall ties 31 Subfloor ventilator 32 33 Damp proof course Base course 34 Foundations 35 36 Solum Floor joists 37 Floorboards 38 Water tank 39 Hot water tank 40

Reference may be made in this report to some or all of the above component parts of the property. This diagram may assist you in locating and understanding these items.
