# Home Report

9 Ballinard Road  
Broughty Ferry Dundee DD5 3LG

# Single Survey

Property Address	9 Ballinard Road Dundee DD5 3LG
Customer	Rees Dow & Yvonne Dow
Prepared by	Graham + Sibbald LLP
Date of Inspection	26/05/2025

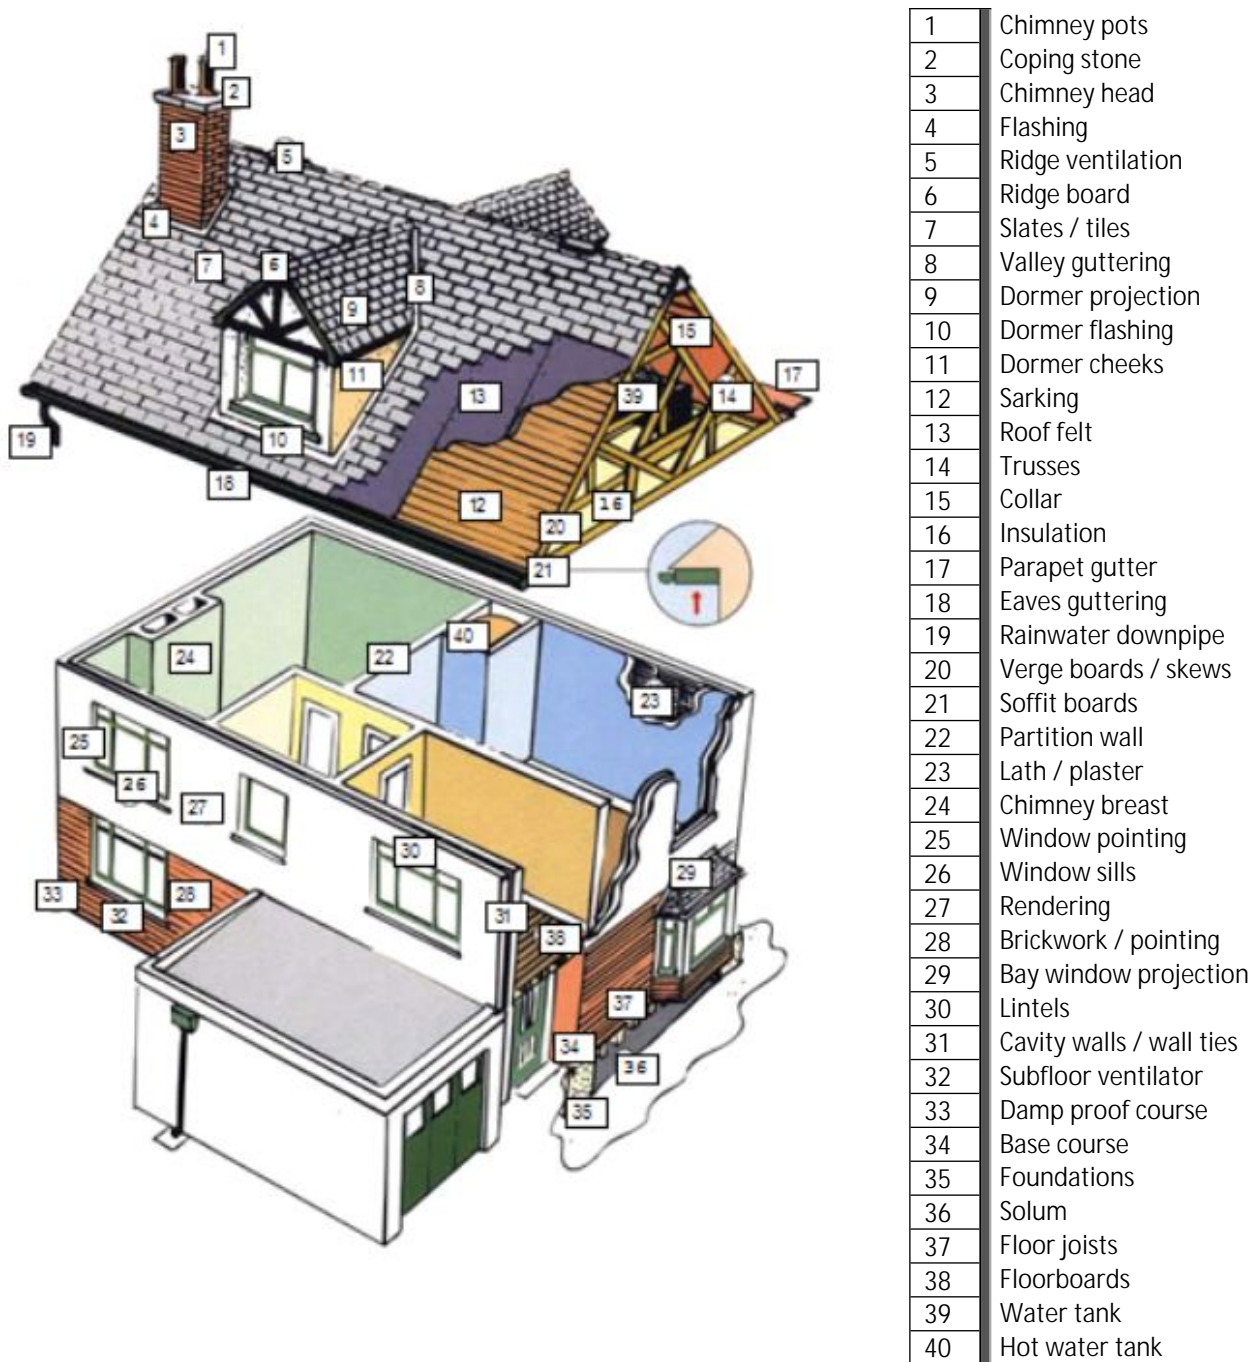
Sectional diagram showing elements of a typical house

Reference may be made in this report to some or all of the above component parts of the property. This diagram may assist you in locating and understanding these items.
