Home Report

7 Scotswood Terrace
Dundee DD2 1PA

Single Survey

| Prepared by | Graham + Sibbald Property Consultants Limited |

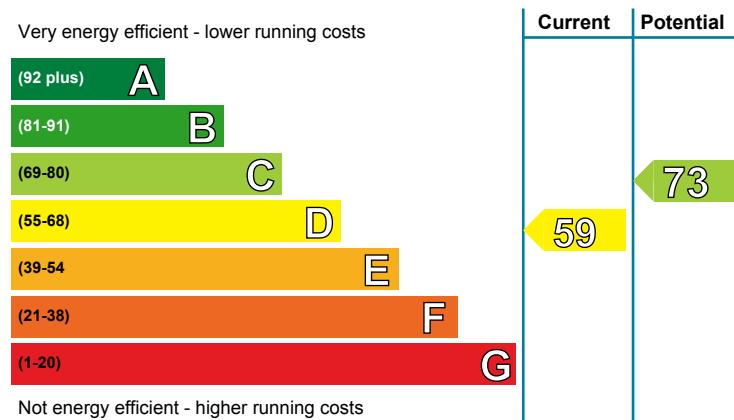
Energy Efficiency Rating

This graph shows the current efficiency of your home, taking into account both energy efficiency and fuel costs. The higher this rating, the lower your fuel bills are likely to be.

Your current rating is **band D (59)**. The average rating for EPCs in Scotland is **band D (61)**.

The potential rating shows the effect of undertaking all of the improvement measures listed within your recommendations report.

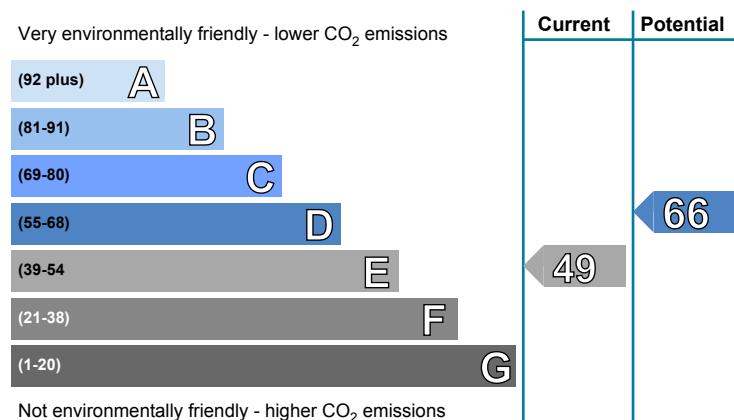
Environmental Impact (CO₂) Rating

This graph shows the effect of your home on the environment in terms of carbon dioxide (CO₂) emissions. The higher the rating, the less impact it has on the environment.
