# Home Report

33A/1 Church Street  
Broughty Ferry Dundee DD5 1HB

# Single Survey

<b>Property Address</b>	33A/1 Church Street Dundee DD5 1HB
<b>Customer</b>	Eric Ramsey
<b>Prepared by</b>	Graham + Sibbald Property Consultants Limited
<b>Date of Inspection</b>	17/02/2026

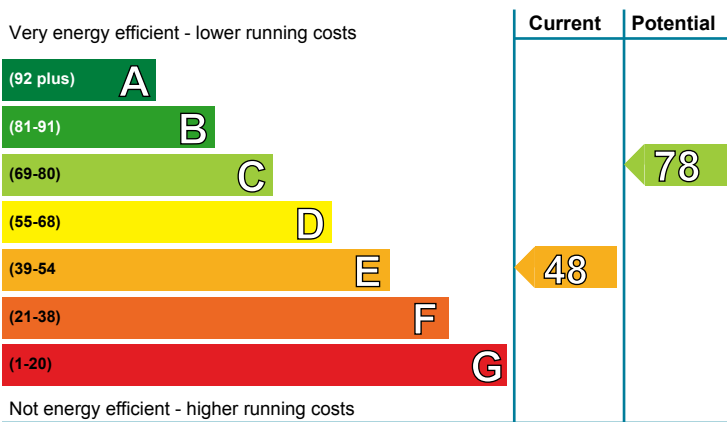
## Energy Efficiency Rating

This graph shows the current efficiency of your home, taking into account both energy efficiency and fuel costs. The higher this rating, the lower your fuel bills are likely to be.

Your current rating is **band E (48)**. The average rating for EPCs in Scotland is **band D (61)**.

The potential rating shows the effect of undertaking all of the improvement measures listed within your recommendations report.

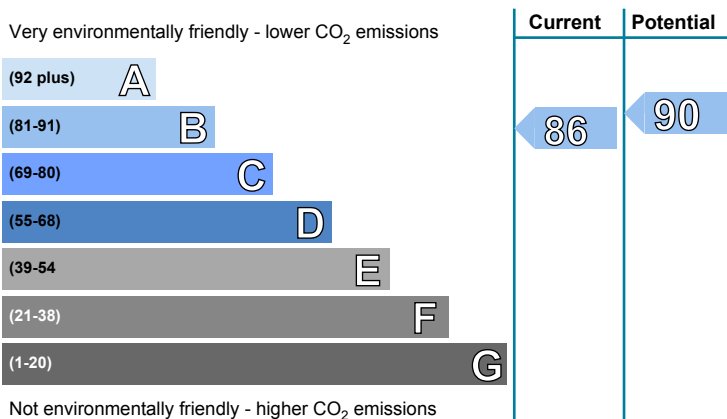
## Environmental Impact (CO<sub>2</sub>) Rating

This graph shows the effect of your home on the environment in terms of carbon dioxide (CO<sub>2</sub>) emissions. The higher the rating, the less impact it has on the environment.
