1 Naughton Place,
Dundee,
DD2 2JR

Home Report

Property Address	1 Naughton Place, Dundee, DD2 2JR
Reference	DD202606-61853
Customer Name	Jean Dallas Executry
Date of Inspection	4th June 2026
Surveyor's name, qualifications and office	Jack Chinery AssocRICS DM Hall LLP Chartered Surveyors Shed 26, Unit 34, City Quay Camperdown Street Dundee DD1 3JA Tel: 01382 873100 email: dundeeresidential@dmhall.co.uk
Prepared By	DM Hall LLP

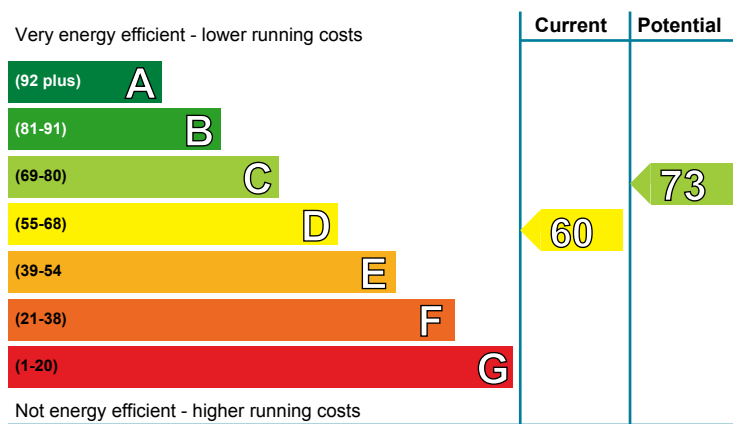
Energy Efficiency Rating

This graph shows the current efficiency of your home, taking into account both energy efficiency and fuel costs. The higher this rating, the lower your fuel bills are likely to be.

Your current rating is **band D (60)**. The average rating for EPCs in Scotland is **band D (61)**.

The potential rating shows the effect of undertaking all of the improvement measures listed within your recommendations report.

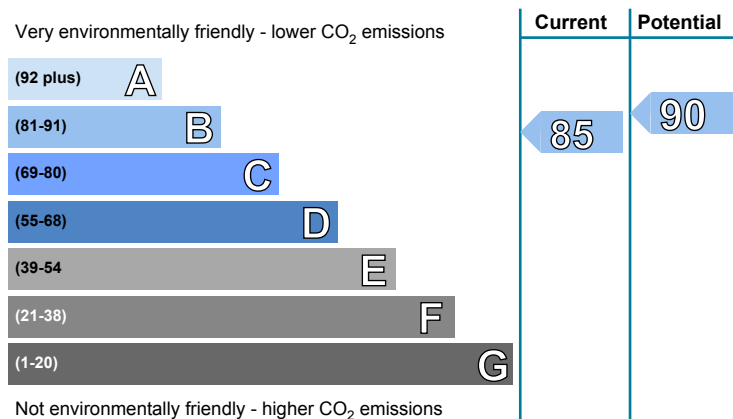
Environmental Impact (CO₂) Rating

This graph shows the effect of your home on the environment in terms of carbon dioxide (CO₂) emissions. The higher the rating, the less impact it has on the environment.
